# Self-Sinking Caisson Failure Investigation

Alissa Reitter, Will Conley, Rita Masouras, Maya Norris  
Civil Engineering, University of New Hampshire, Durham, NH 03824

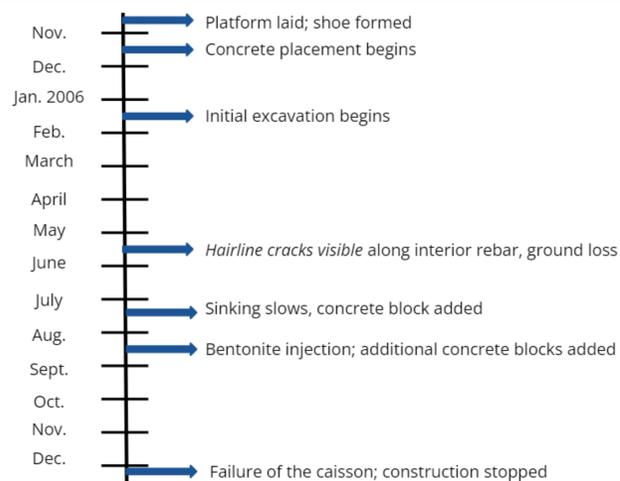
In December 2006, a self-sinking caisson, referred to as Contract 3 or Combined Sewer Overflow Unit 14 (CSO 14), shown in Figure 2, experienced a delamination failure in the thick concrete walls of the caisson. The timeline of construction and failure of the caisson is shown in Figure 1.

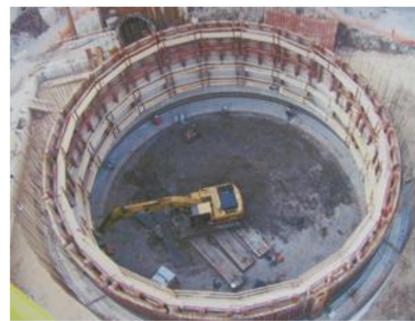
Figure 2: CSO 14, 151' in diameter with 7.5' thick reinforced concrete walls.

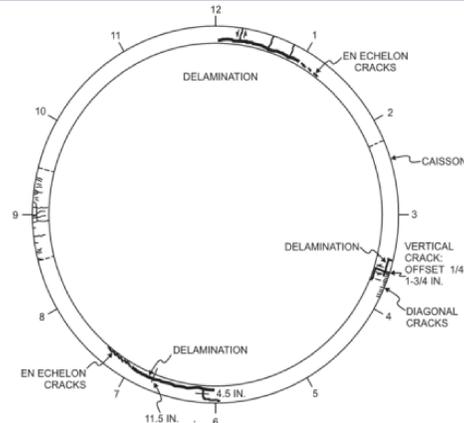
Figure 8: Cracking patterns.

- The soil around the perimeter of the caisson varied in strength, causing the caisson to sink unevenly.
- There was uneven lateral earth pressure acting around the caisson, causing ovaling. Finite element analysis resulted in moments that correspond to the cracking patterns seen.
- The major delamination cracks occurred in the plane of the rebar grid, which corresponds to stress concentrations estimated herein.

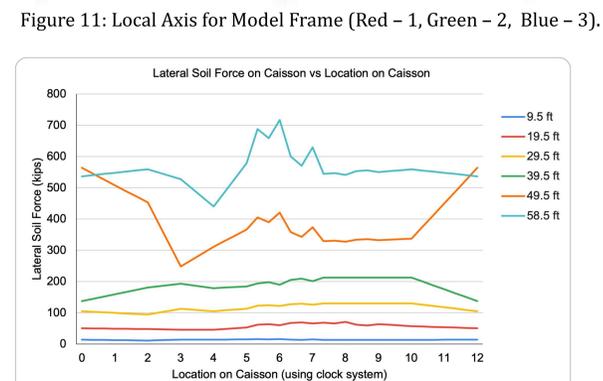
Figure 12: Lateral Soil Force on Caisson vs Location on Caisson.

- The lateral soil force was modeled in SAP2000 using point loads that represent the lateral soil pressure.
- Figures 13 and 14 display the resultant shear and moment respectively for the 2D model of the caisson at a depth of 58.5 ft.
- The maximum shear at a depth of 58.5 ft is 704 kips in compression.
- The maximum moment at a depth of 58.5 ft is 130,600 kip-in in positive bending.
- Figure 13 shows that the lateral soil force on the caisson peaked at 5, 6, 7:00 at a depth of 58.5 ft and 12 and 1:00 at a depth of 49.5 ft.
