# METAL WAREHOUSE ROOF COLLAPSE INVESTIGATION

Sarah Moriarty, Brandon Loisel, Marco Gioioso, Alex Croteau  
 Sponsor: Simpson Gumpertz & Heger  
 Faculty Advisor: Dr. Ray Cook

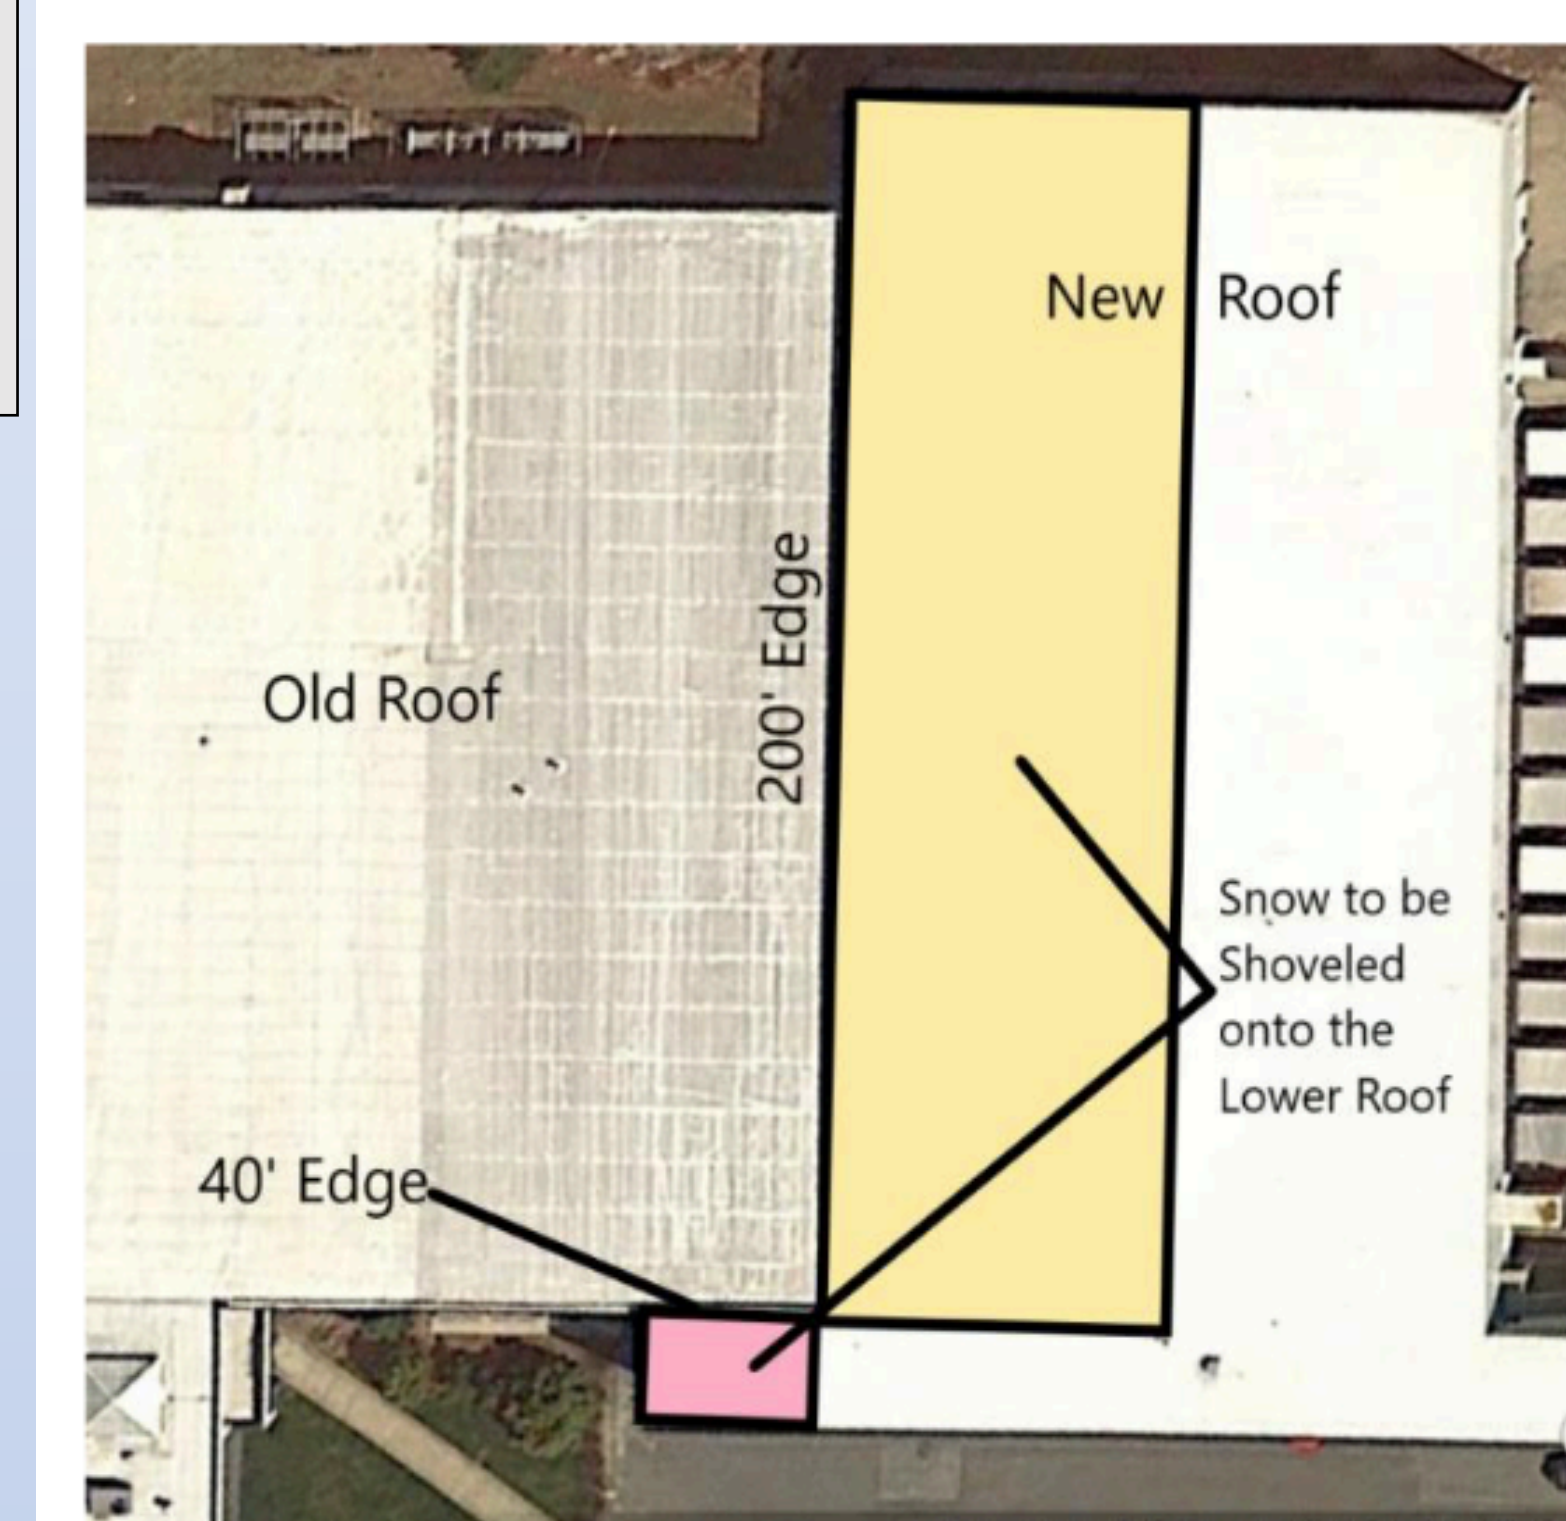
Ultimately, it was determined that there was an excess snow load shoveled onto the original, lower roof. In the investigation, it was also determined that the roof purlins were the most likely failure members. In conjunction with a potential flaw in construction, excessive snow load was hypothesized to be the reason for collapse.

Figure 10: Sources of Additional Snow Load

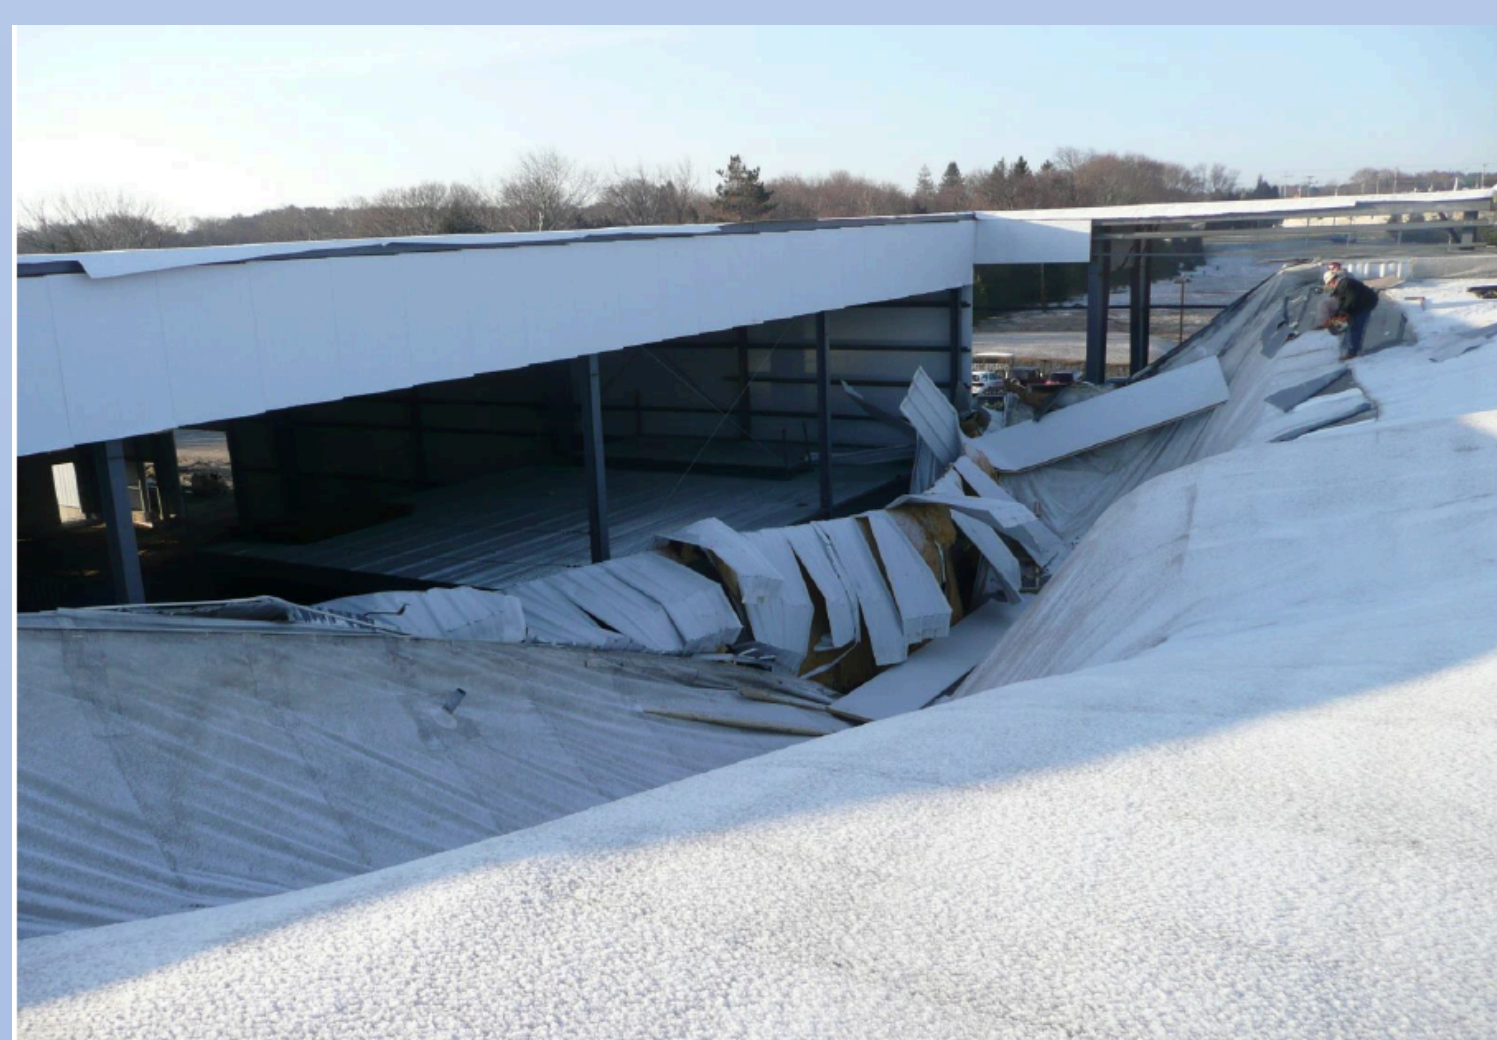
Figure 2: South View of Collapse

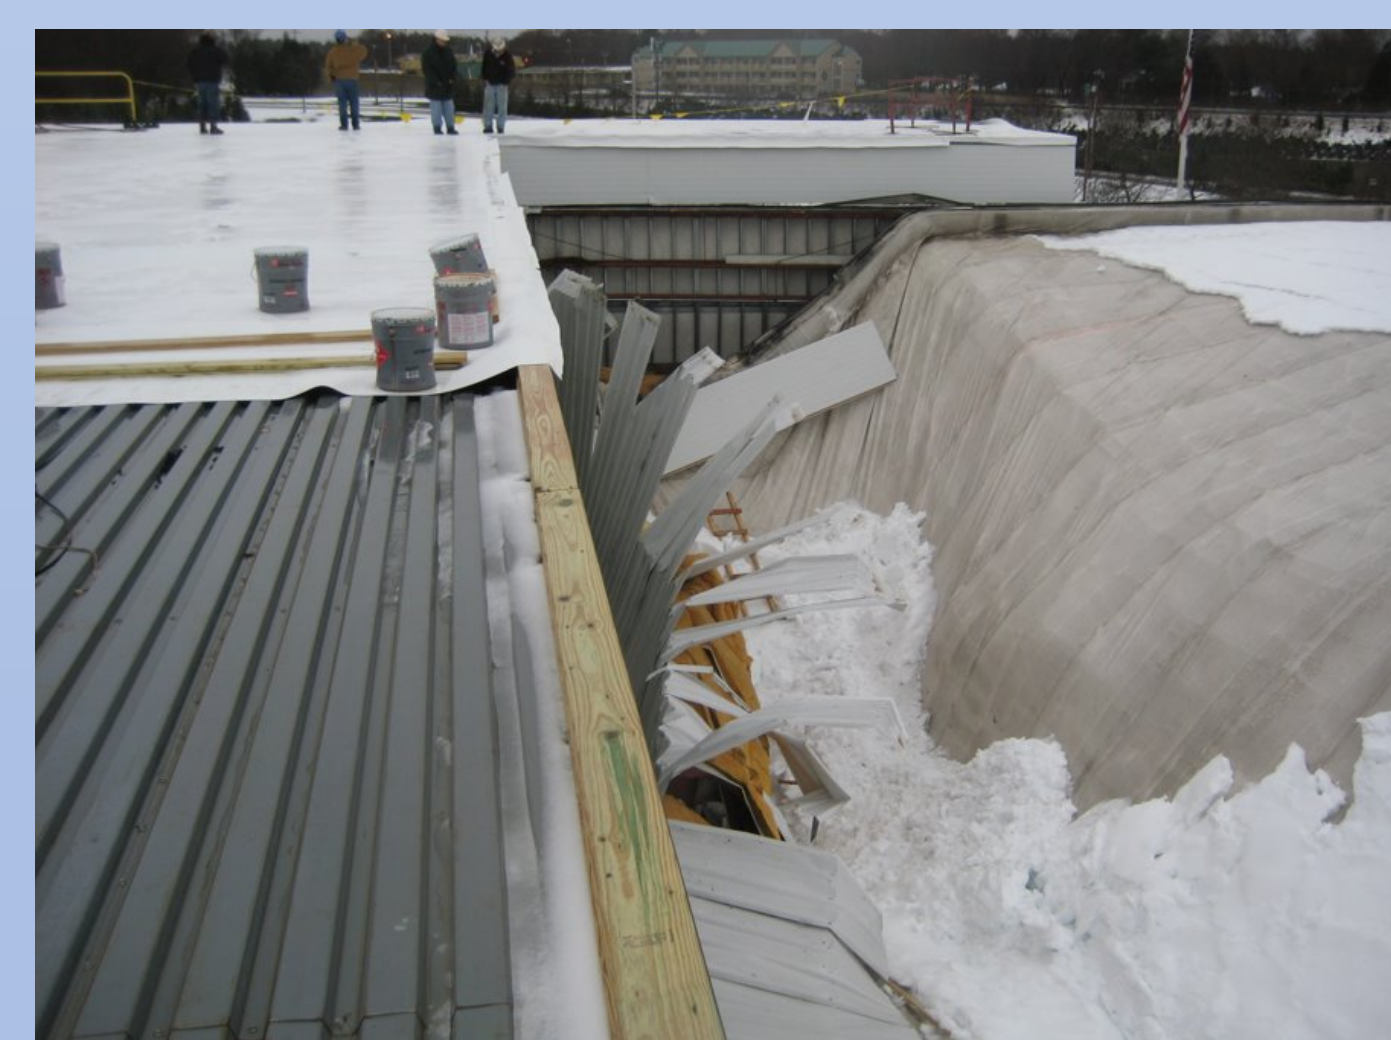
Figure 3: South View of Collapse

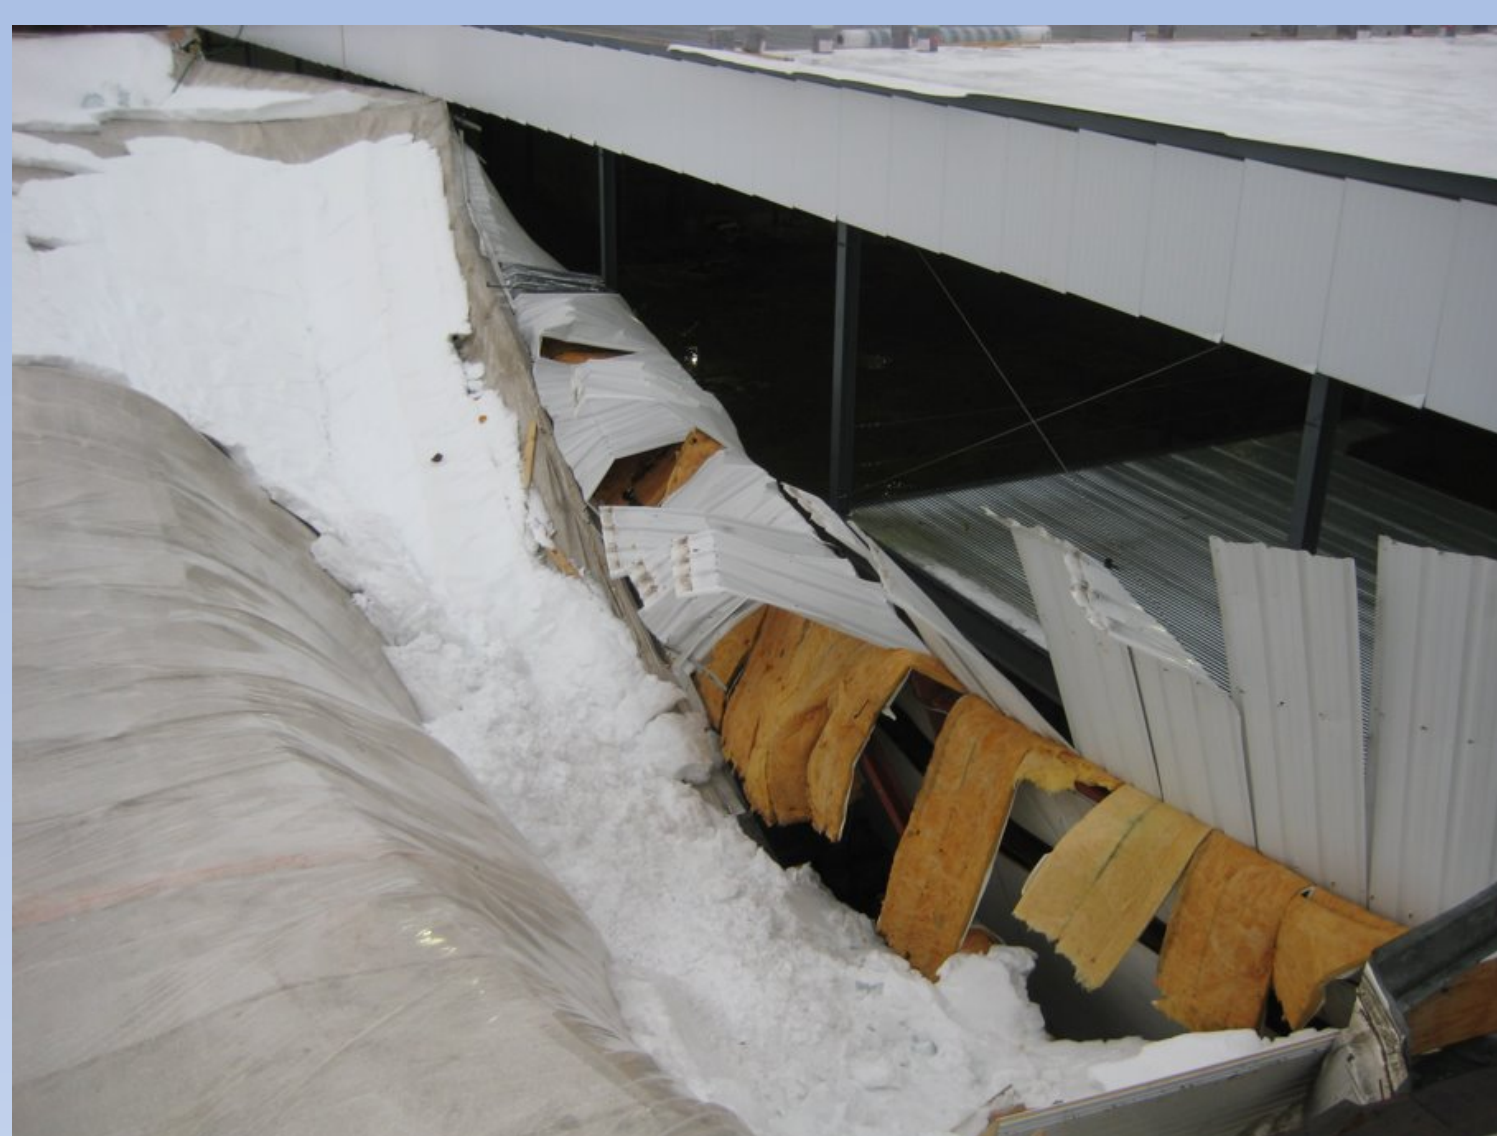
Figure 5: North View of Collapse

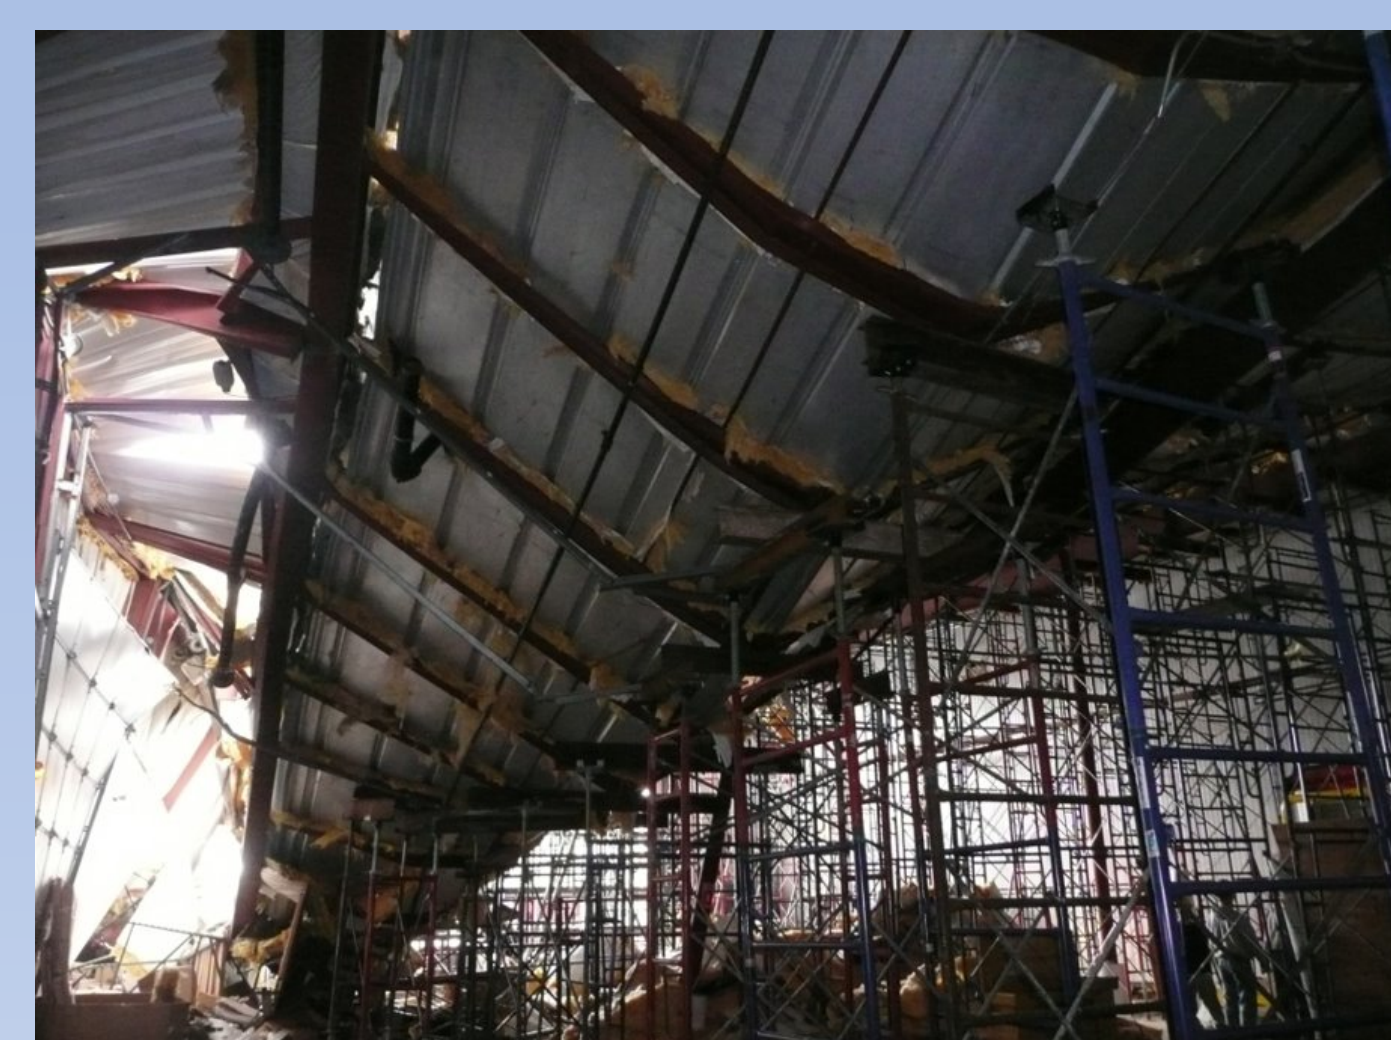
Figure 6: Interior South View of Collapse

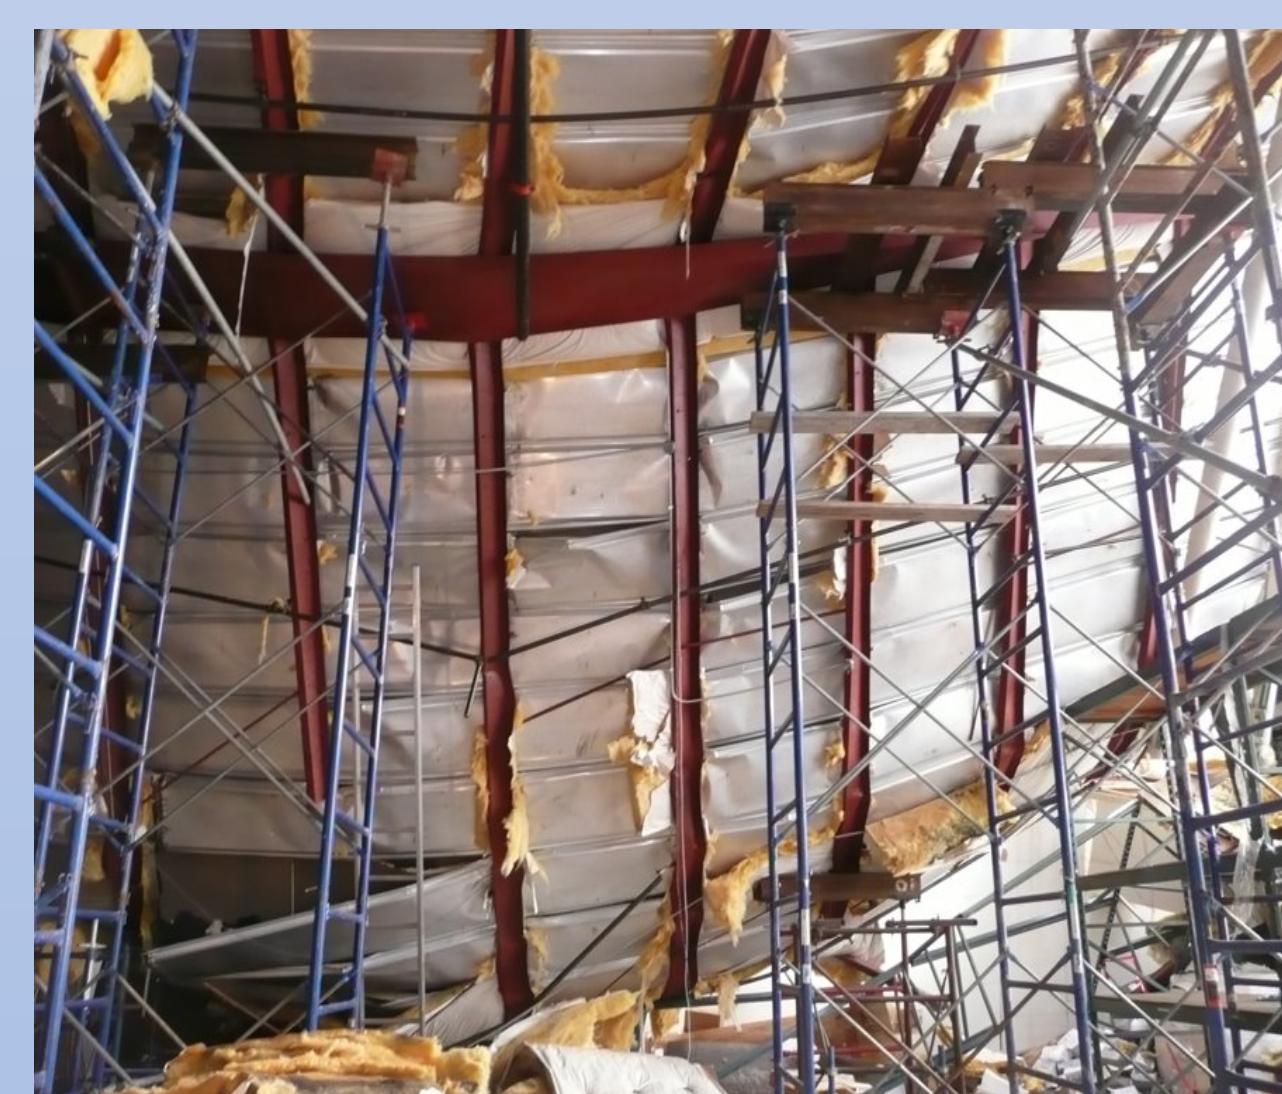
Figure 4: Interior View of Collapse

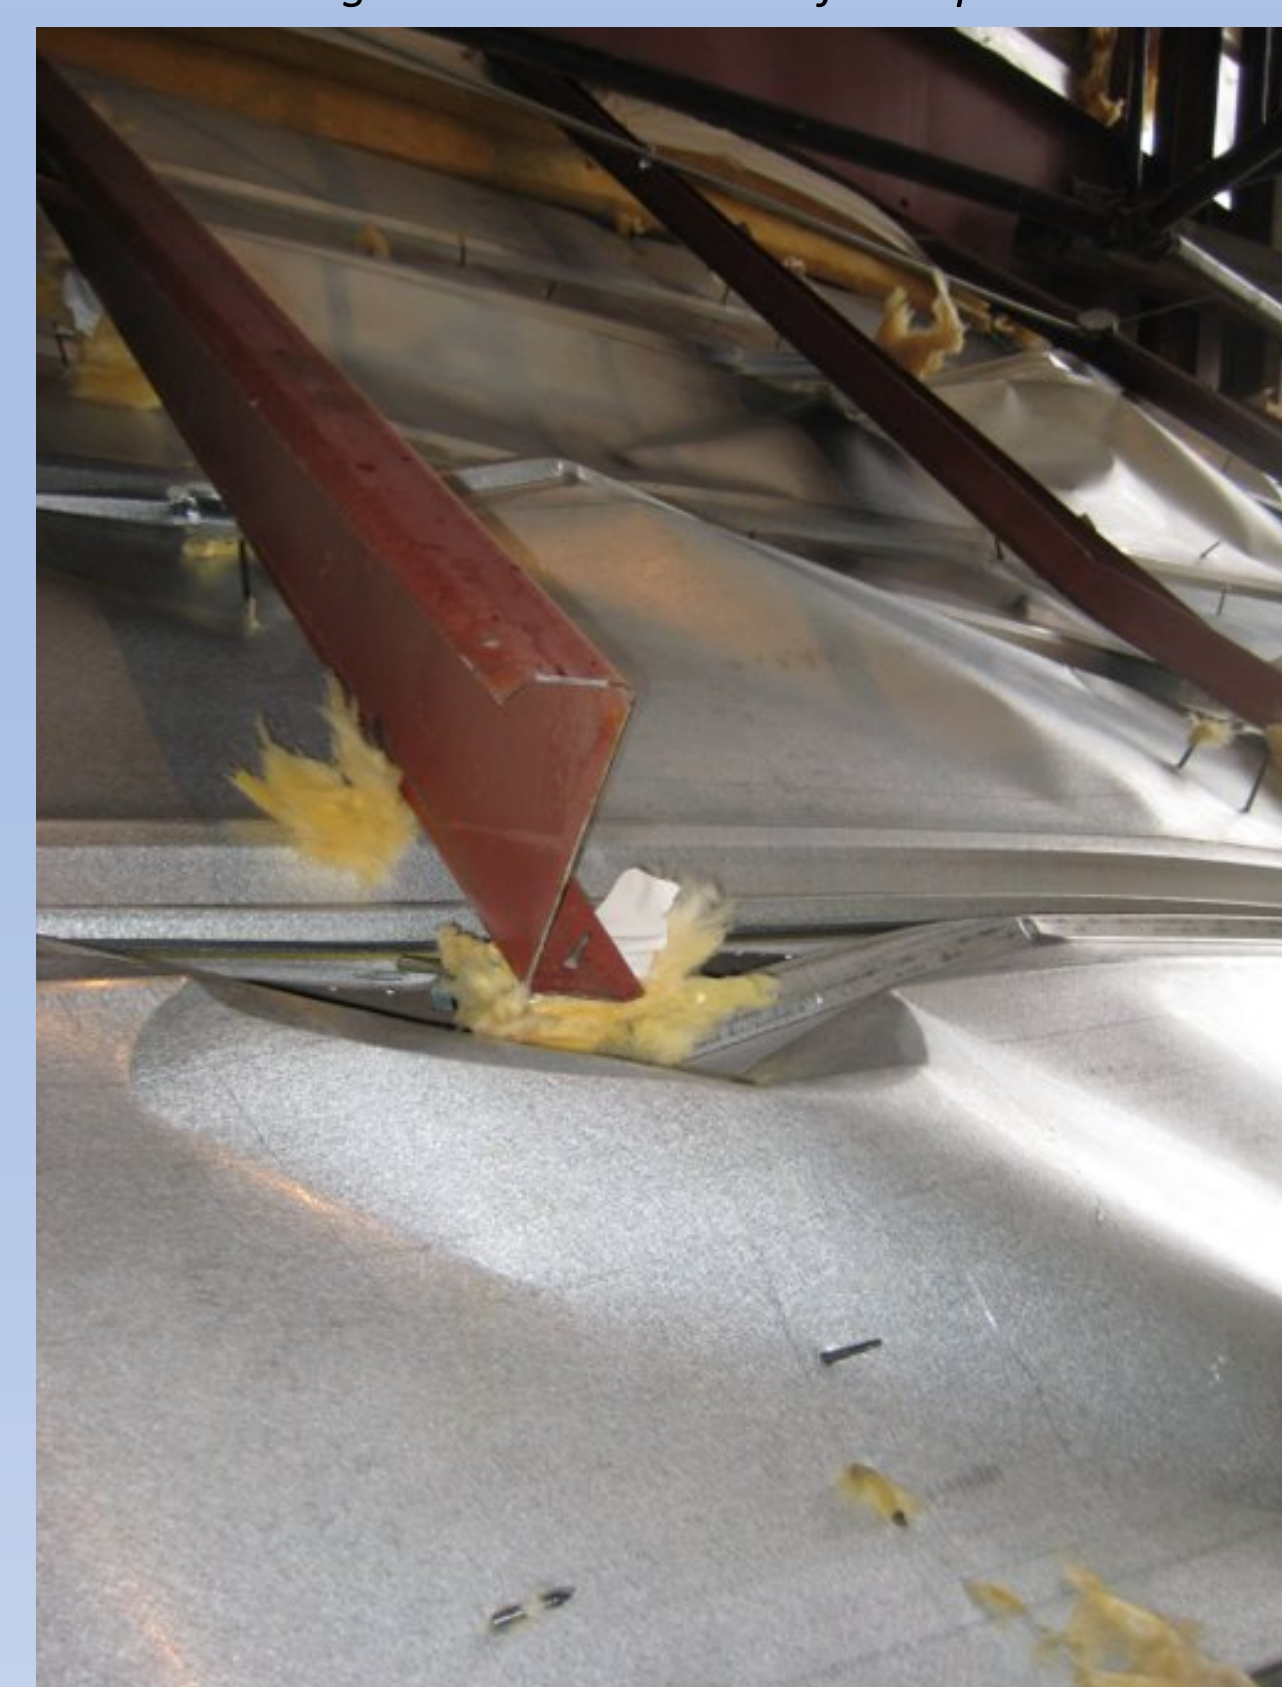
Figure 7: Faulty Purlin Splice

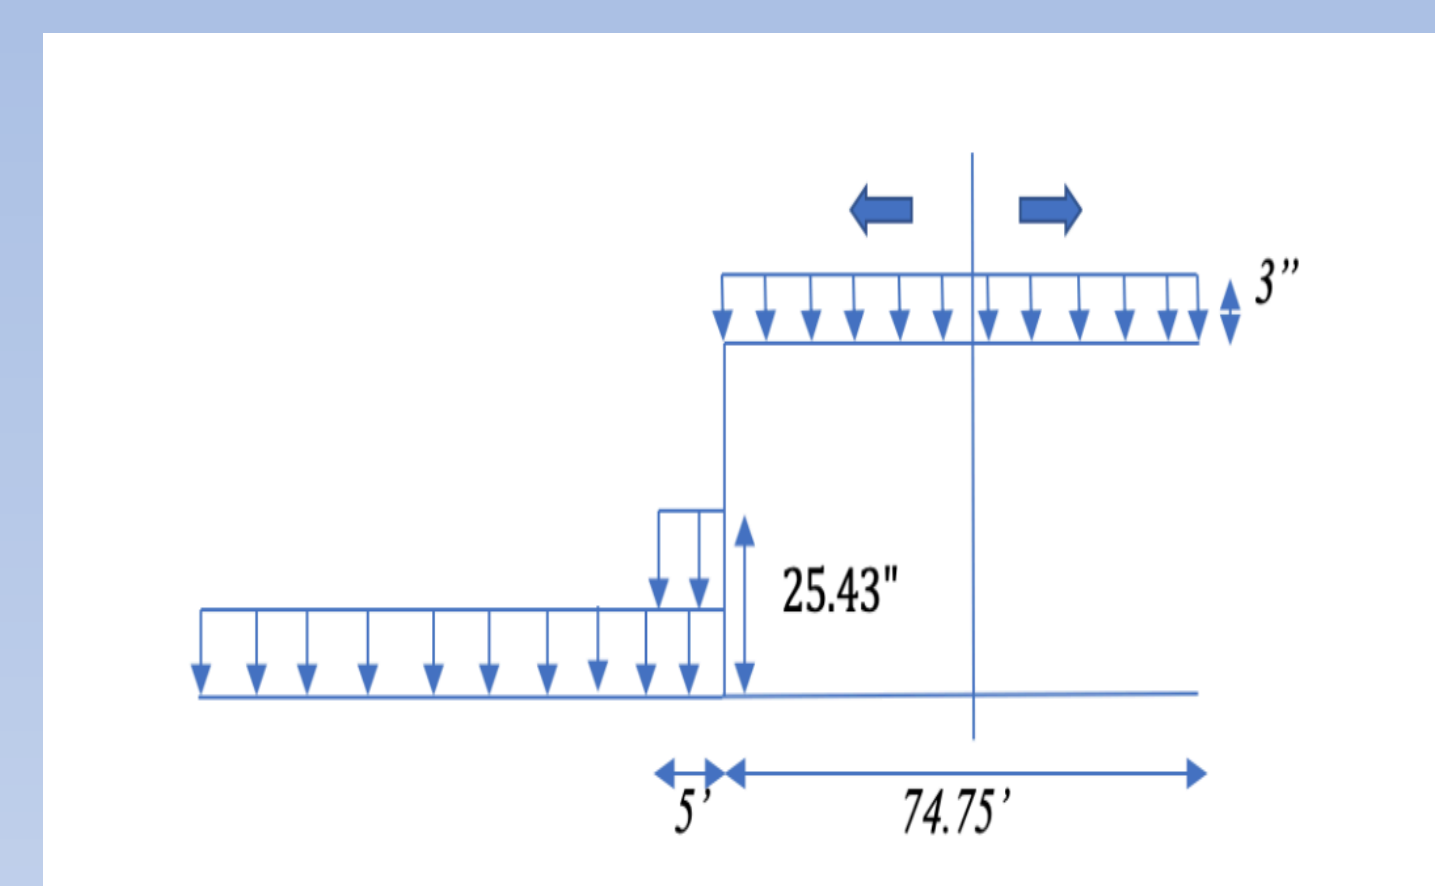
Figure 9: Distributed Snow Load

The design snow load was far lower than the snow load the roof experienced on January 7<sup>th</sup>. As shown in the table to the right, on average, three inches of snow would have a normal distributed load of 5 psf on the roof on any given section. The issue occurred when workers shoveled the snow into the condensed 5-foot section. Figure 9 shows how the volume of the section was calculated. The arrows indicate which way the snow was shoveled off. We assumed half would be shoveled onto the old roof and the other half was pushed off the other direction. If 3 inches fell onto the entire roof, about two feet of snow would end up in the 5-foot section indicated in Figure 9. This would add 42 psf to the roof when the design snow load was only 30 psf.
