Introduction & Project Goals

Portsmouth Senior Center Structural Assessment Sage Cawthern (PM), Emily Clickner, Joseph Jorgens, Ryan Savoy & Guillermo Sepulveda Project Sponsor: Wunderlich-Malec Engineering Faculty Advisor: Dr. Robert Henry

Structural Assessment

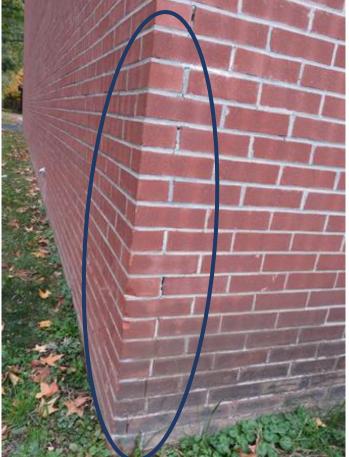
Figure 7: Exterior Wall

Step Cracking

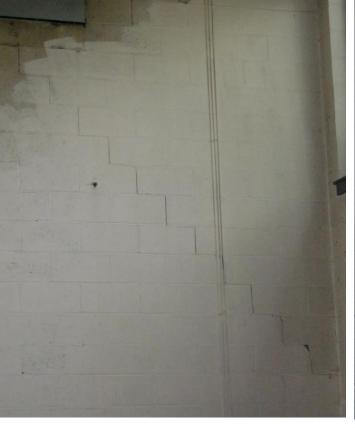
Figure 11: Interior Wall Step Cracking

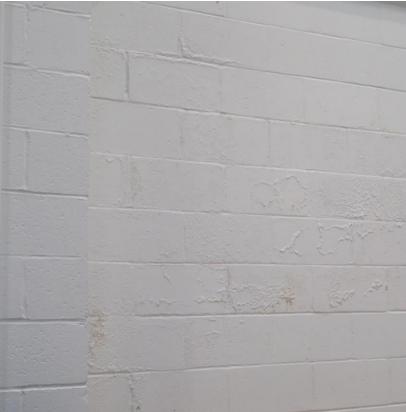
Figure 12: New Paint Bubbling From Interior Moisture

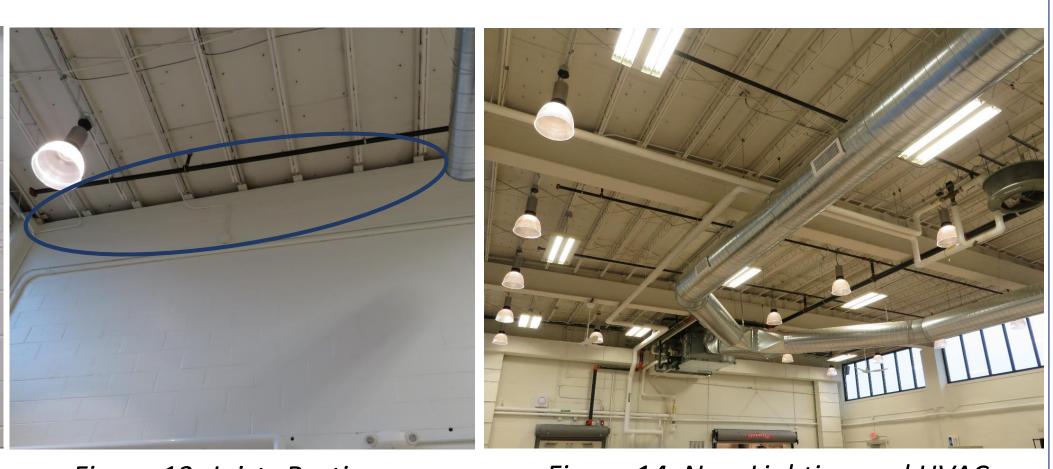
Figure 13: Joists Resting on Masonry Wall

The lack of connection between the joists and walls is a violation of current code guidelines. The lack of reinforcing of the masonry walls does not meet the requirements for a building

Renovation O Anchoring and t elements togeth (Roof angle clips
