Tidal Culvert Analysis in Georgetown, ME

College of Engineering & Physical Sciences, University of New Hampshire, Durham, NH 03824

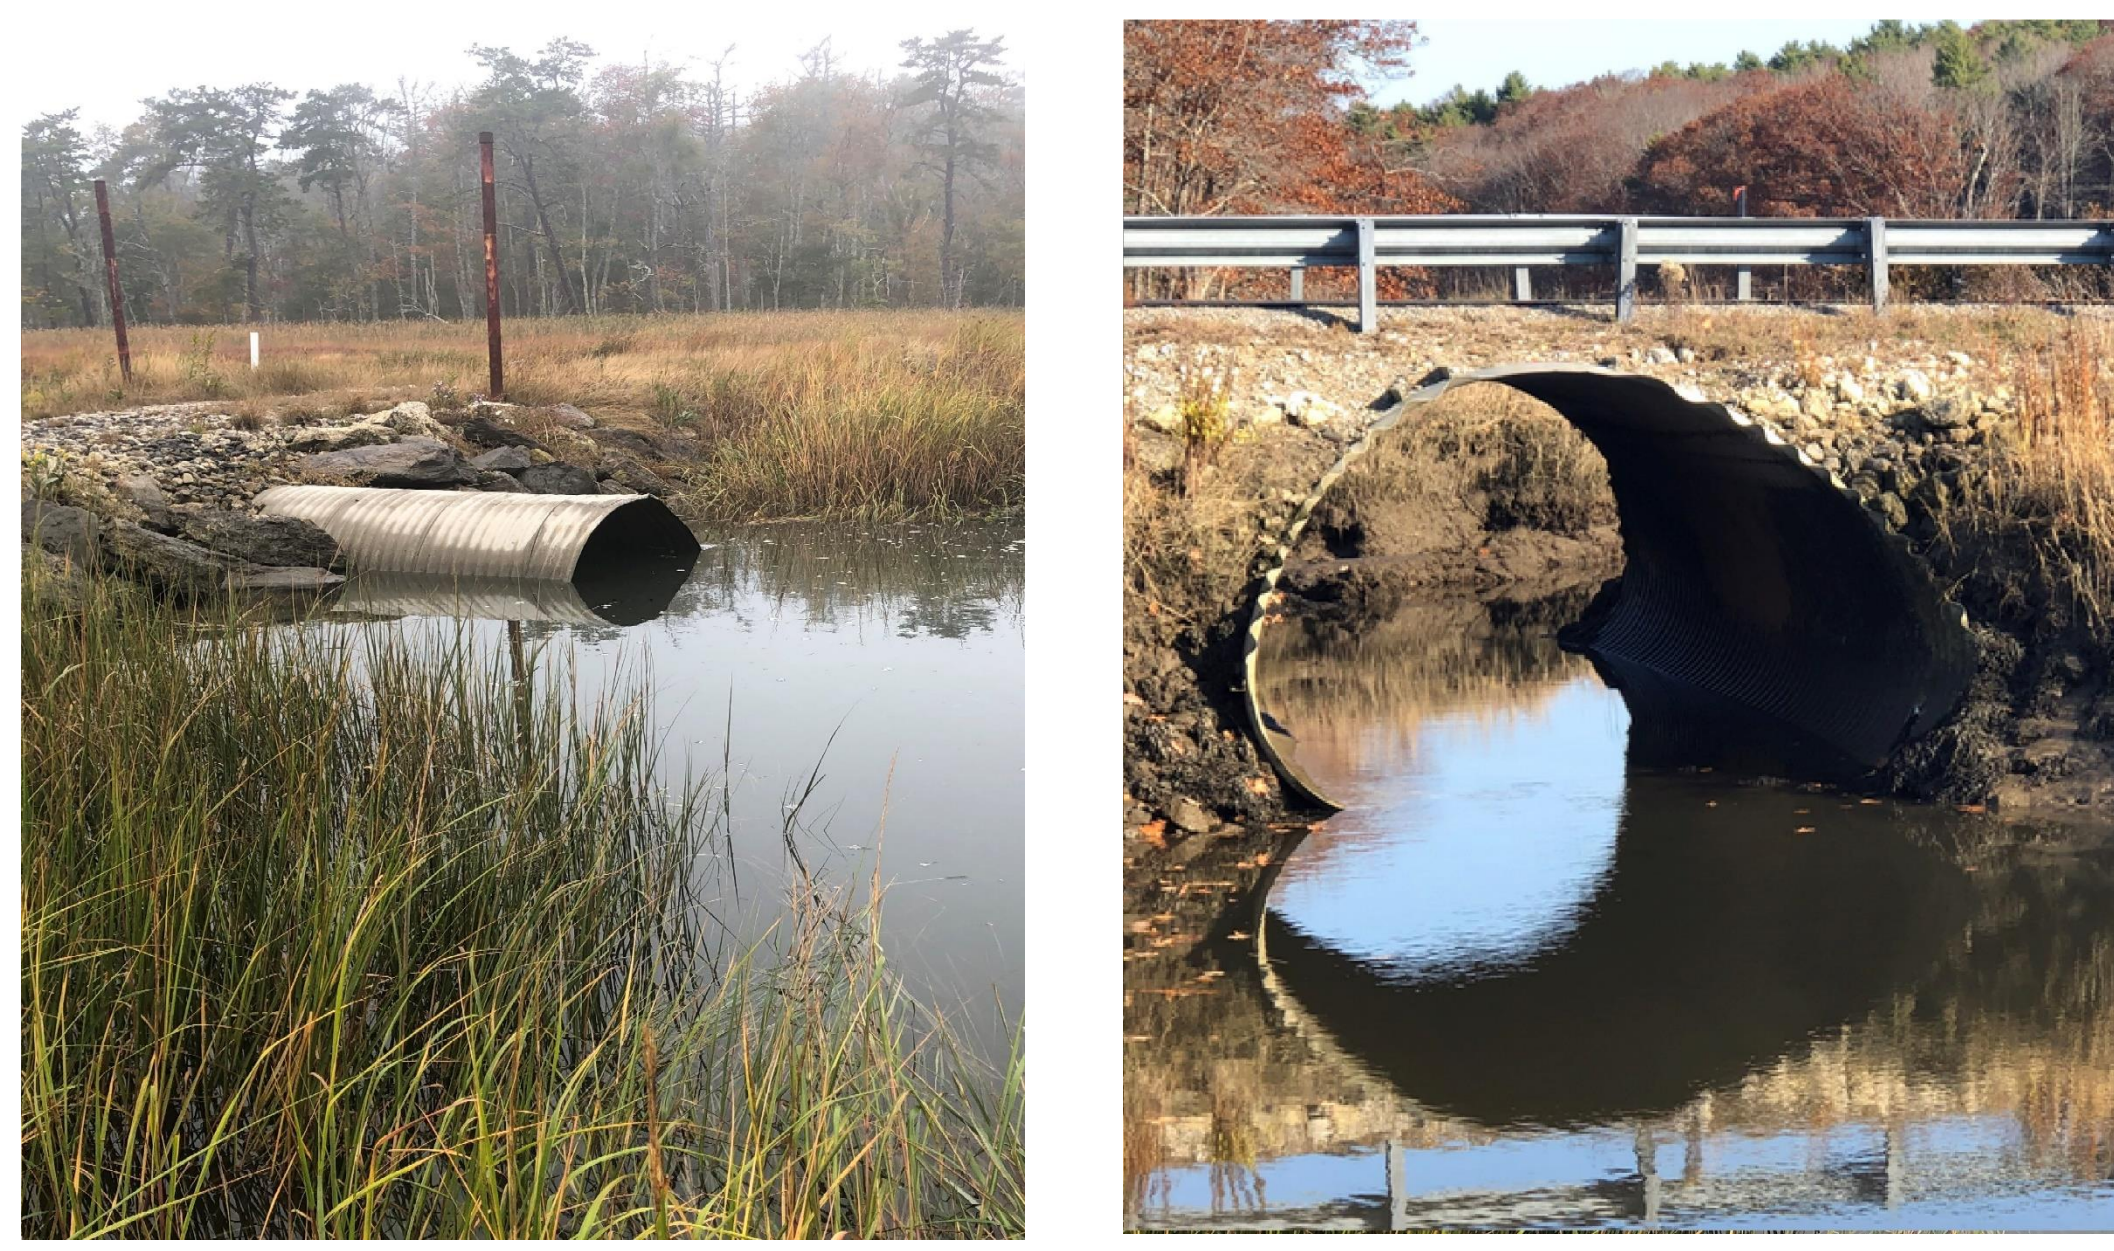
Flying Point Road culvert (left) and Williams Road culvert (right)

The Flying Point Road culvert is a 5' circular corrugated metal pipe. The single-lane gravel road above it connects one household to the Georgetown mainland and serves as a walking route to conservation land managed by the Kennebec Estuary Land Trust (KELT). The crossing frequently floods and the water levels do not appear even upstream and downstream of the culvert at times.

The Williams Road culvert is a 15ft-wide pipe-arch corrugated metal pipe. The State of Maine installed it in 1997 to replace a rotting wooden bridge, but the town owns the paved road above it that connects six households to the Georgetown mainland. The crossing approaches on the marsh occasionally flood at high tide.

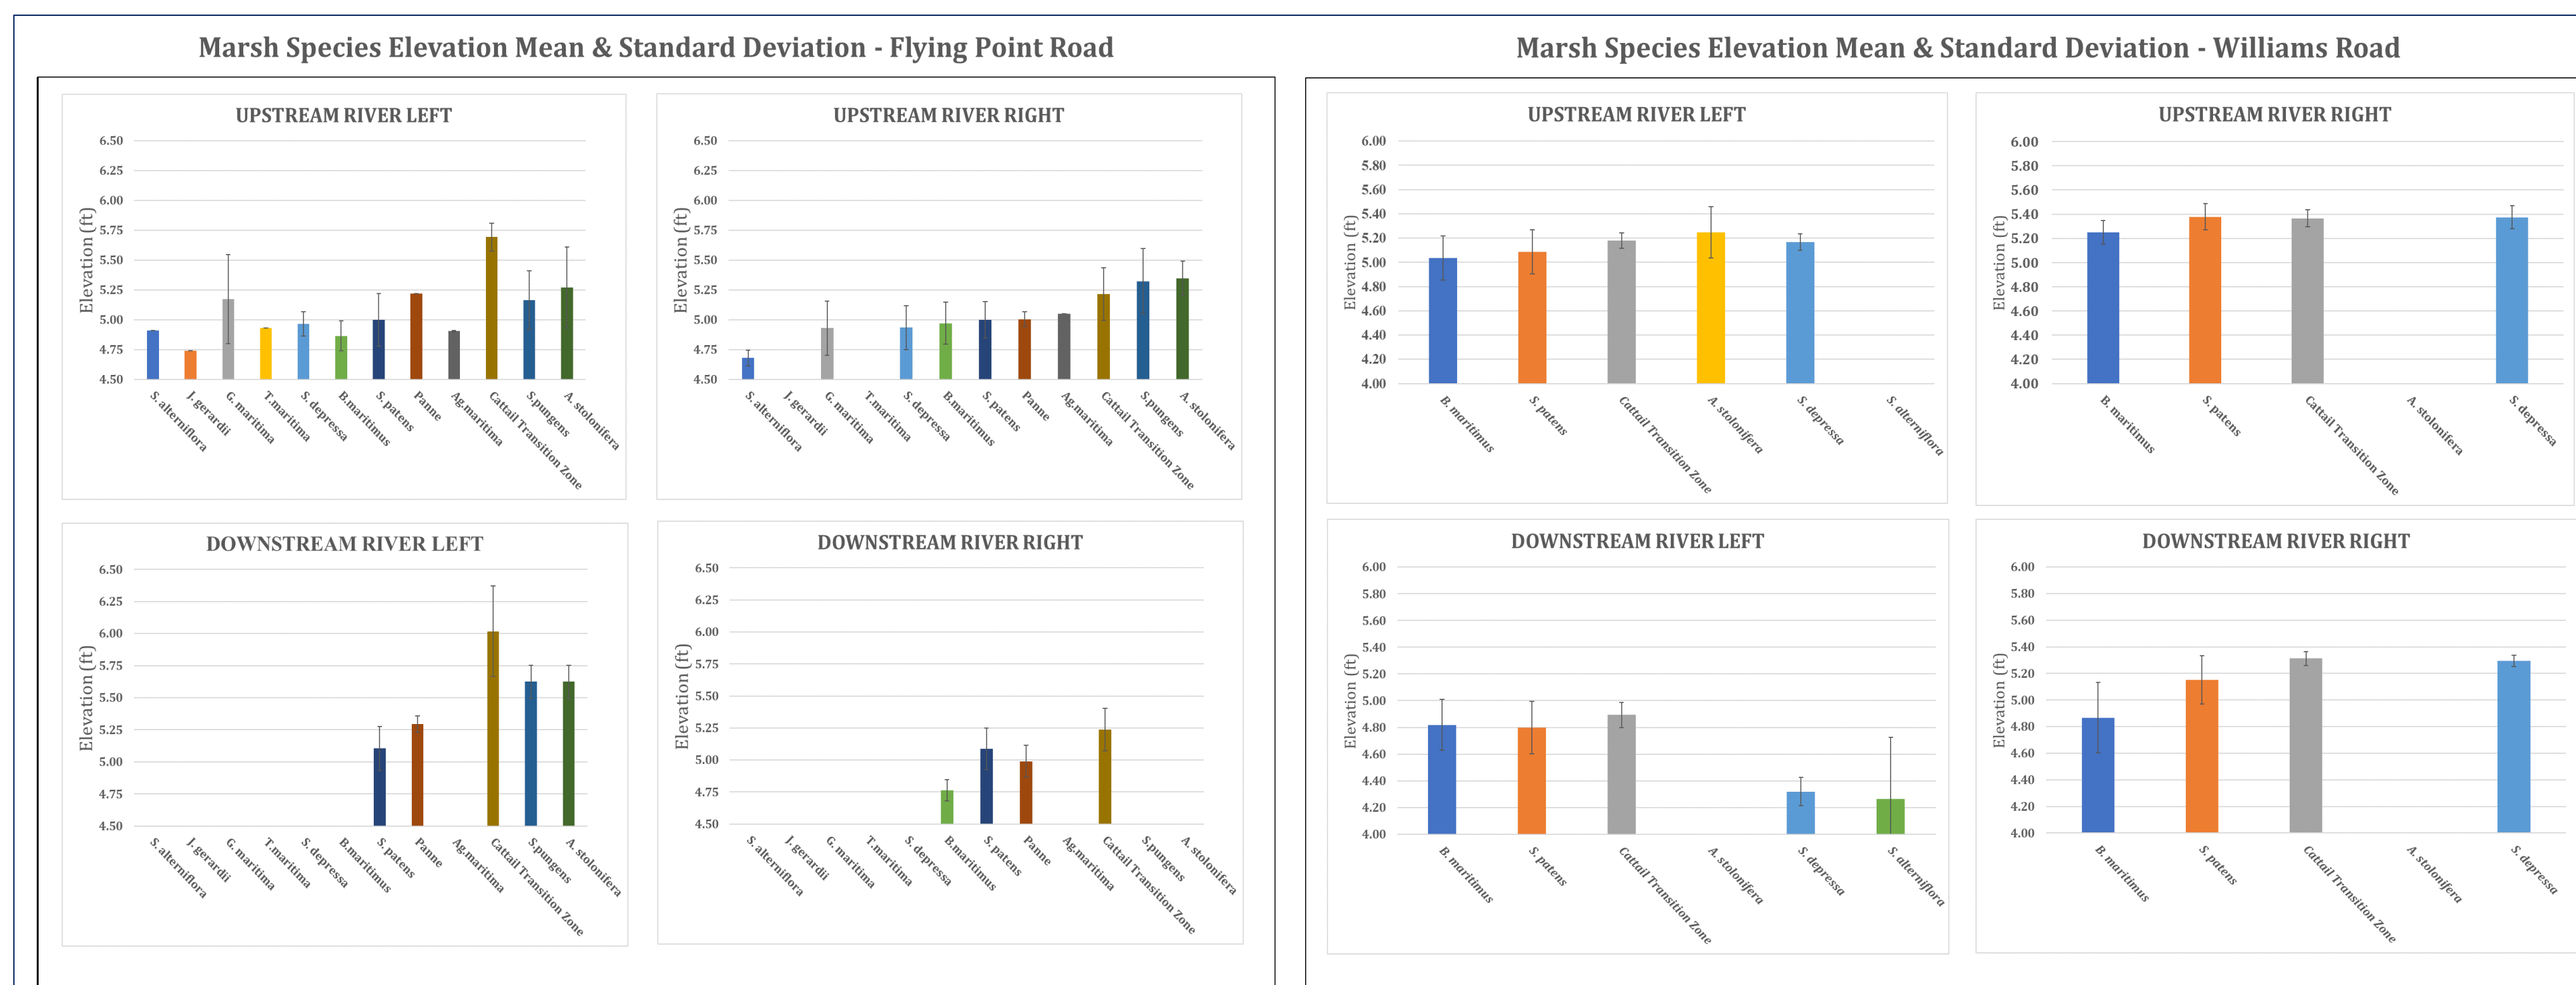
The mean and standard deviation elevation of vegetation species observed around each crossing are displayed by quadrant in the bar charts above.

At Flying Point Road, six of twelve surveyed species were observed both upstream and downstream of the crossing. The intraspecies mean elevations of *A. stolonifera* and *S. pungens* were significantly different.

At Williams Road, four of six surveyed species were observed both upstream and downstream of the crossing. The intraspecies mean elevations of *B. maritimus*, *S. patens*, and *S. depressa* were significantly different.

Intraspecies vegetation elevation differences upstream and downstream of the Flying Point Road culvert were largely not significant, including the most inundation-sensitive species observed: *S. patens*. This indicates the tidal restriction at Flying Point Road is likely not the cause of any observed elevation differences. Several intraspecies differences at Williams Road were significant but are likely caused by other factors because the culvert does not restrict flow into or out of the marsh.
