Closed Door Machining

Benjamin Seprosovo

Department of Mechanical Engineering, University of New Hampshire, Durham, NH 03824

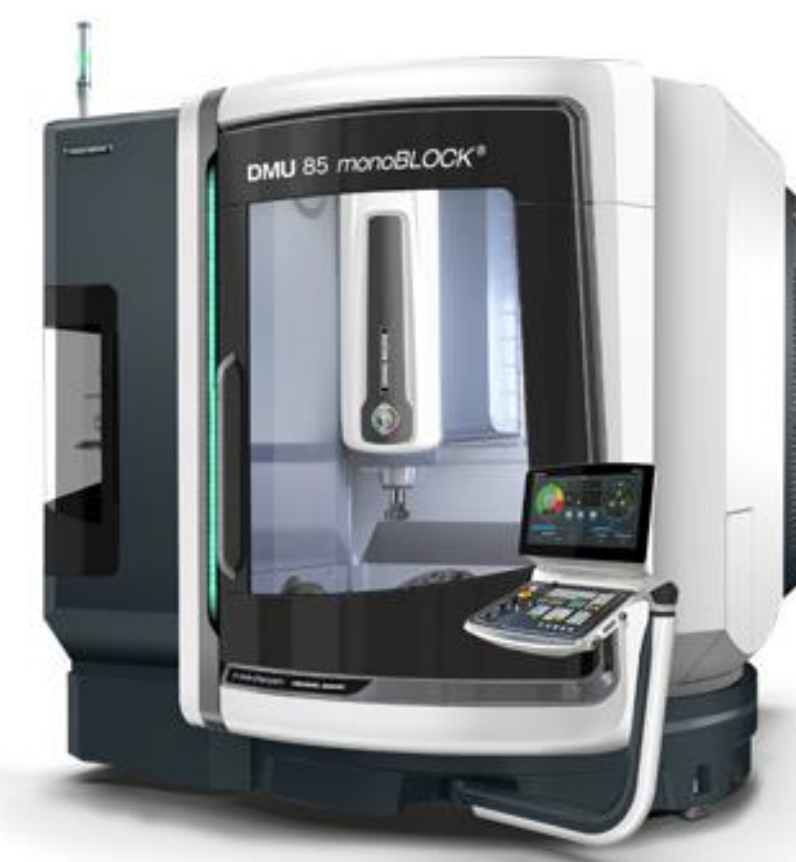
DMU 85 monoBLOCK by DMG MORI

Computer Numerical Control Machine

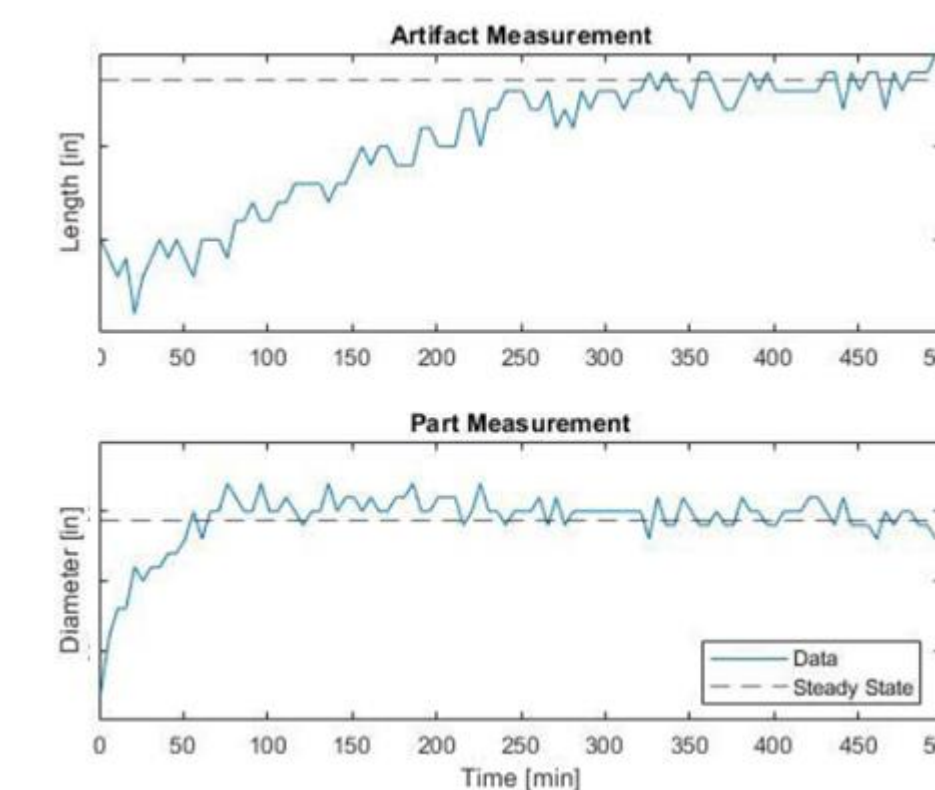
Heat Transfer Test Results

- The heat transfer test was then performed to ensure the rates were comparable between artifact and part. It was discovered that the heat transfer rate was much slower, with the artifact taking 400% longer than the part to reach the steady state temperature.

- Two solutions to this problem were developed. In order to continue testing with the current artifact a coolant flush was introduced to bring both part and artifact to a known temperature.

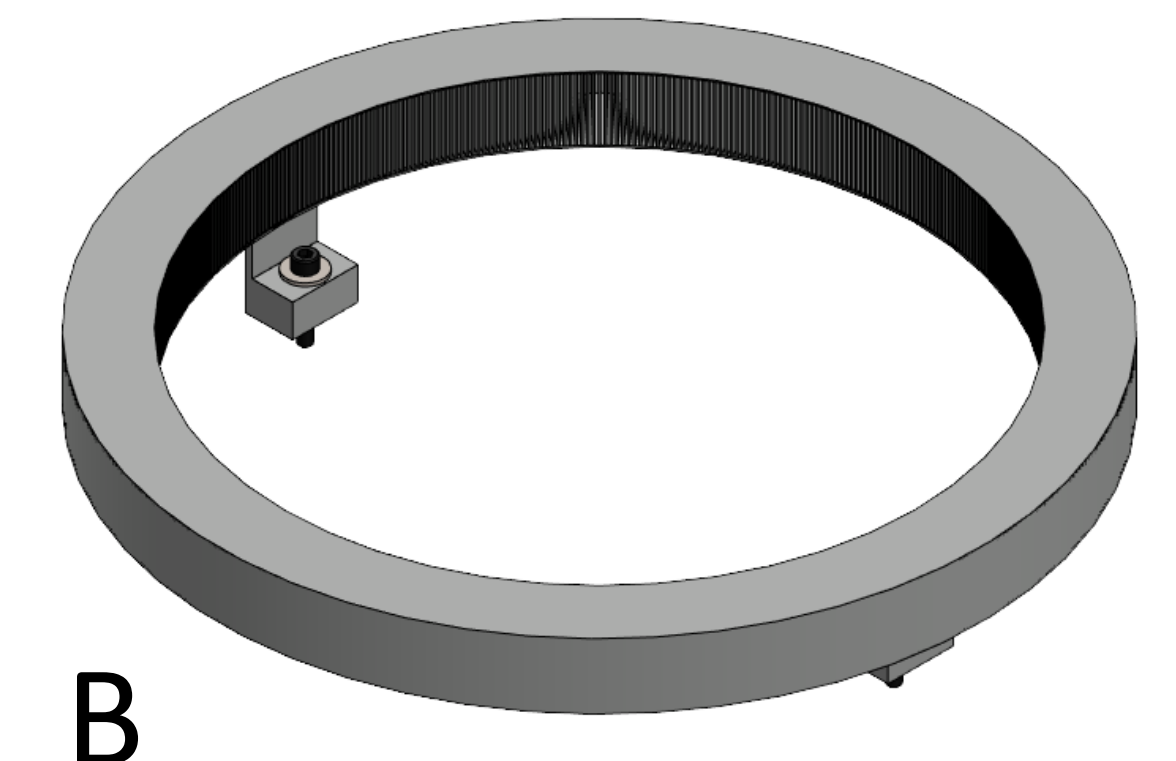
Artifacts Moving Forward

Alternate design A: The original artifact concept was broken down into three pieces to conform with printer restrictions. Several methods of increasing the surface area were explored including radially arranged holes, and vertical hole patterns. Fins were chosen to maximize the surface area. This allows the artifact to match the heat transfer rate of the part more closely. Segments will be connected by a tight-fitting tongue-in-groove secured by two bolts so as not to allow for flexing or loss in thermal expansion. Each slot also has a slightly angled bottom to a drainage trench to prevent the accumulation of coolant in the artifact.

Alternate design B: Fins of 0.025" thickness are arranged radially in a circle with an outer diameter of 9" allowing it to be printed in one piece. The fins are enclosed on three sides to prevent coolant and metal shavings from getting caught in the fins. The outer diameter allows for probing in two dimensions which can be used to as a quality control measure for comparison. In addition, the spacing of the fins can be adjusted to match the surface area of the part much more closely. In this model, there is less than a 2% difference between the surface areas of the artifact and test part.

In both designs, the parts would require finishing machining for placement of mounting hardware and removal of printing supports.

The design of a new artifact was undertaken with the understanding that future artifacts would be 3D printed. This set some limitations on the design:

- Bed Size: 9.8" x 12.8"
- Nominal Feature Tolerances: +/- 0.005"
- Minimum wall thickness: 0.018"
- Vertical rod aspect ratio limit: 3:1
- Maximum Unsupported Overhang Angle: 45°
