# Lafayette Brook Bridge Rehabilitation

Tyler Stanley, Chris Gouveia, Michael Beaudoin, Thomas Mierzwa  
Civil and Environmental Engineering, University of New Hampshire, Durham, NH 03824

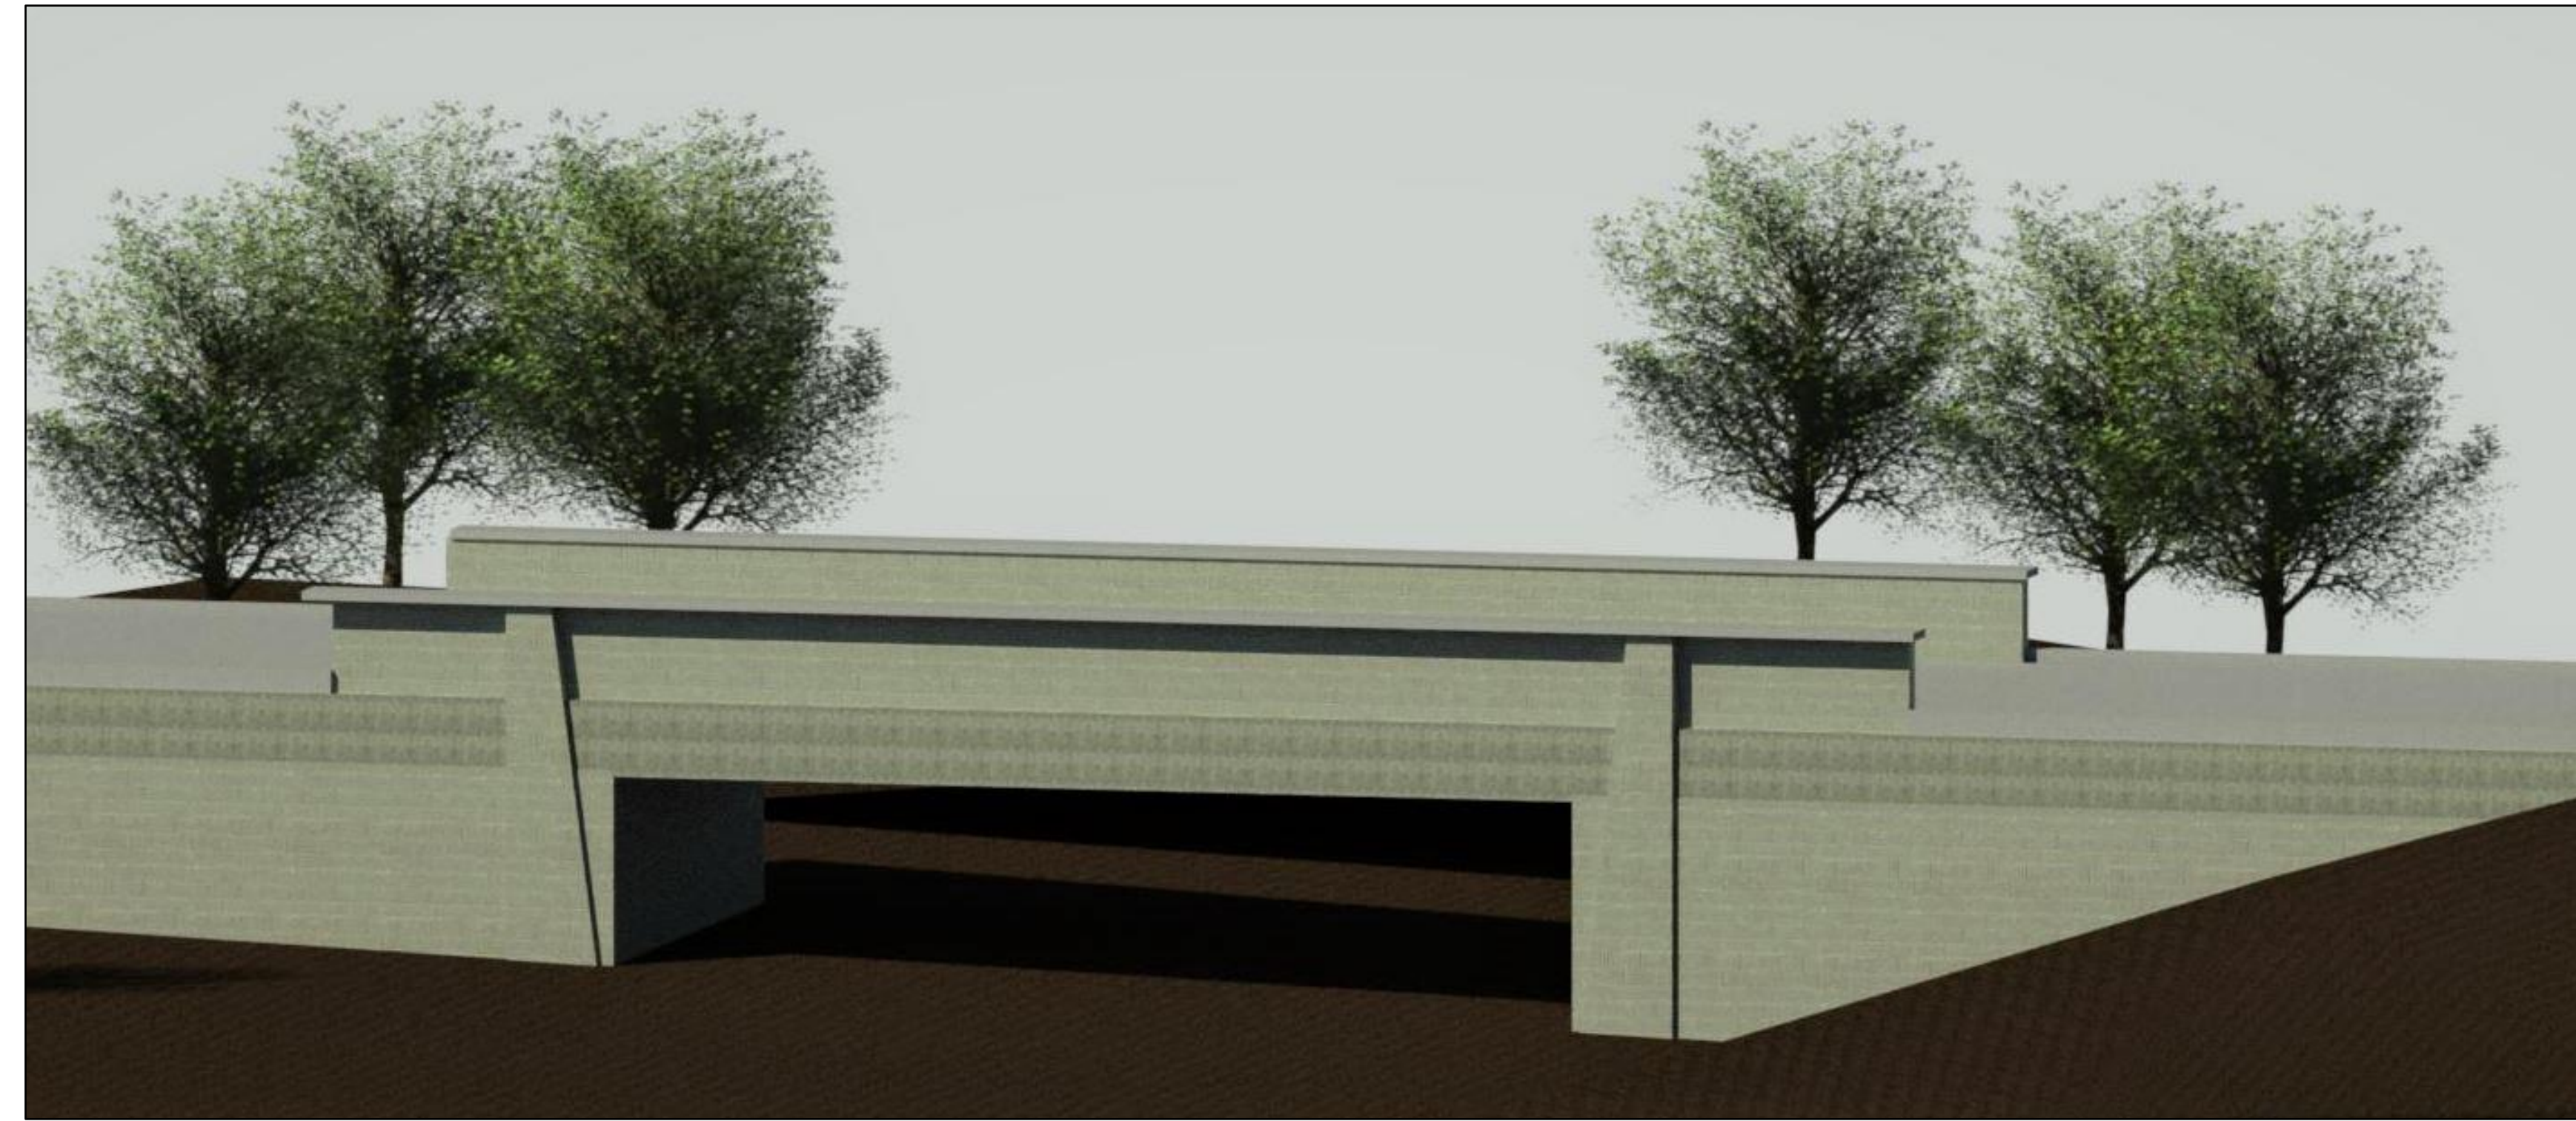
## Traffic Detour Plan

- **2 miles** of additional travel to end up at the north end of the bridge on Profile Road
- **10 minutes** of additional travel time
- **4 - 6 weeks** estimated construction time
- **Rapid reconstruction** will decrease disturbances/displacement of local businesses and residences.

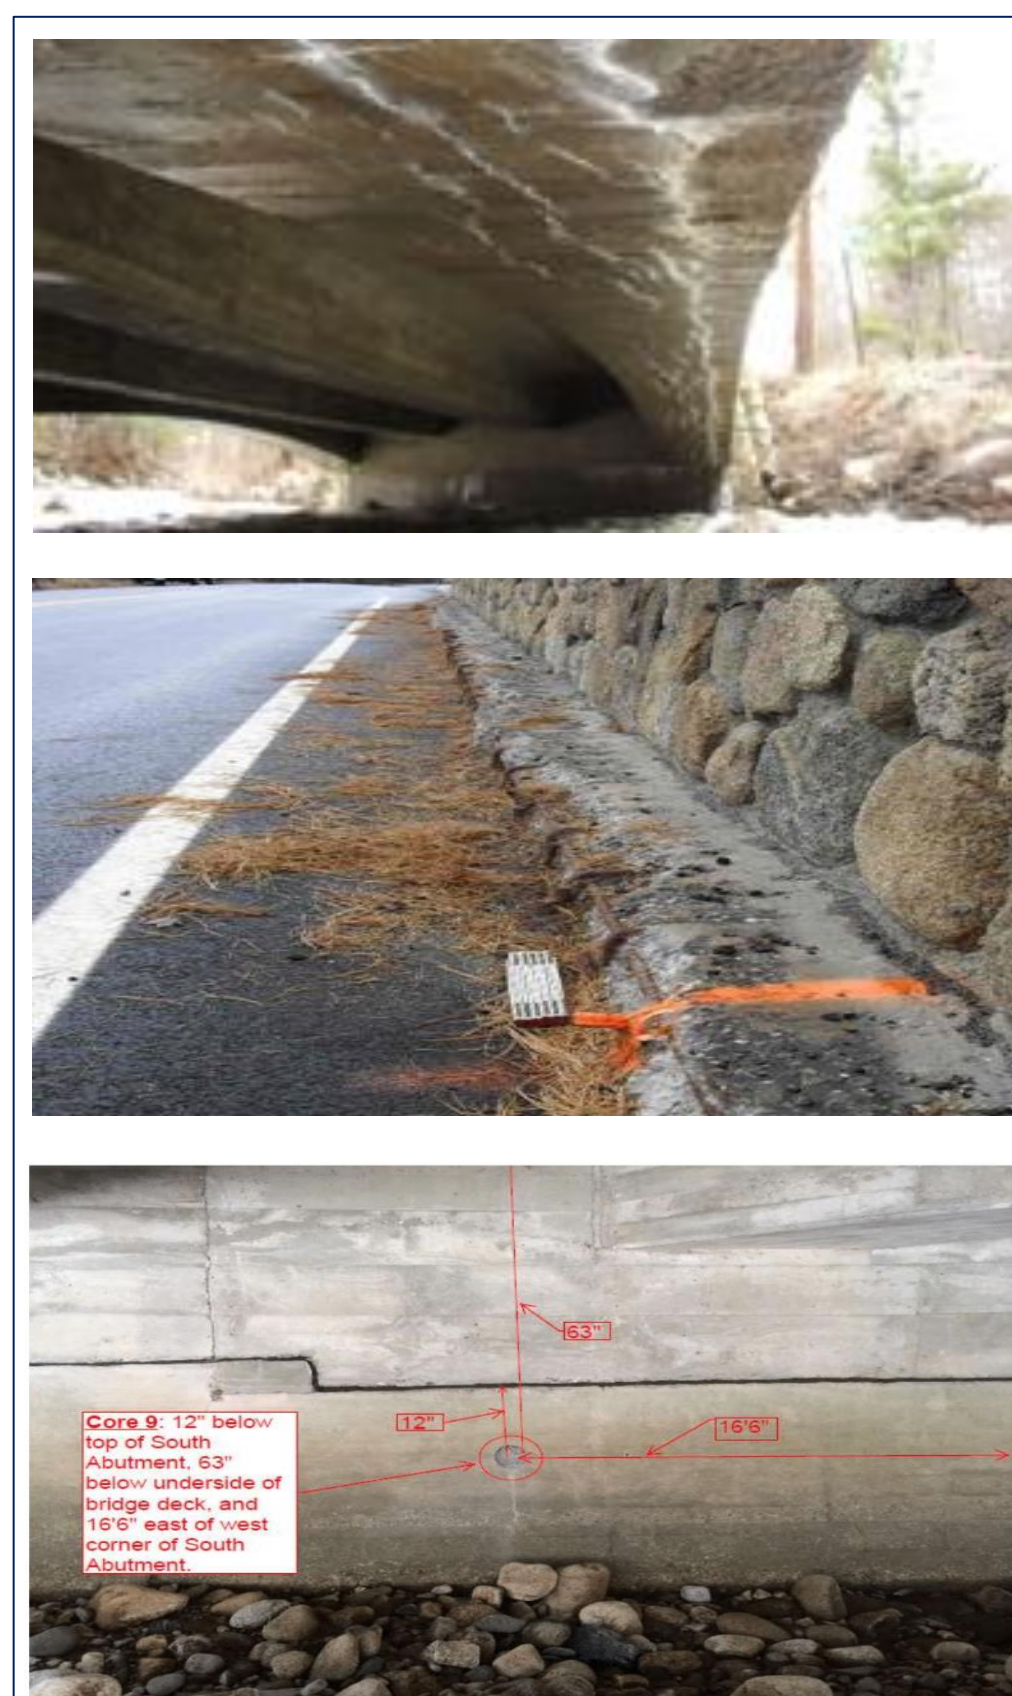
## Existing Conditions

**SUPERSTRUCTURE**  
Cracking, minor spalls, efflorescence, delamination and elevated chloride levels present in several parts of the superstructure including concrete T-beam structures.

**DECKING**  
Northwest and Southeast ends of the bridge deck revealed fractures with considerable leakage elevated chloride levels present and exposed rebar on both the surface and underside of the bridge's decking.

**SUBSTRUCTURE**  
Concrete coring tests revealed a compressive strength of 6000 psi concluding that the abutments are in acceptable condition based on both visual inspection and empirical testing.

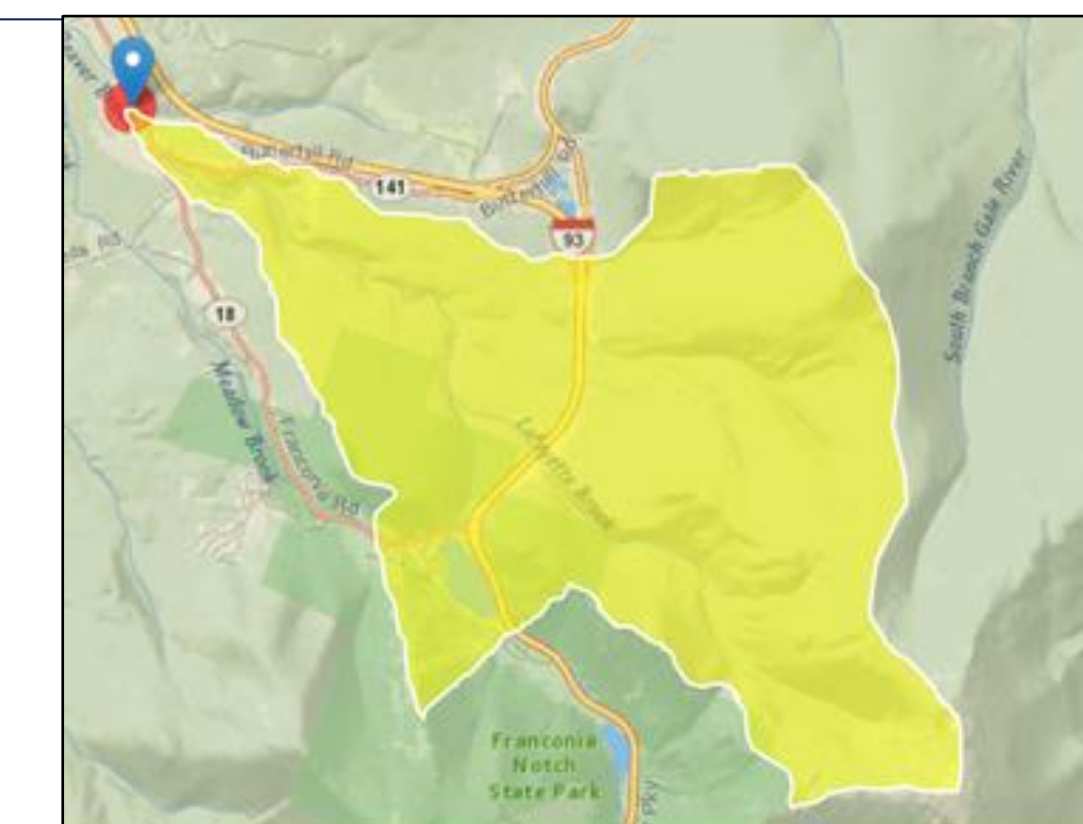
Runoff area delineated from the bridge is 6.53 square miles with an overall channel slope of 27.39%

36% tree cover, helping to reduce the peak flows.

**FEMA Flood Zone A:**  
1% probability of flooding each year.
