Clothespin Bridge Replacement

Oliver Soares, Luke Senter, Joseph Napoli
Civil Engineering, University of New Hampshire, Durham, NH 03824

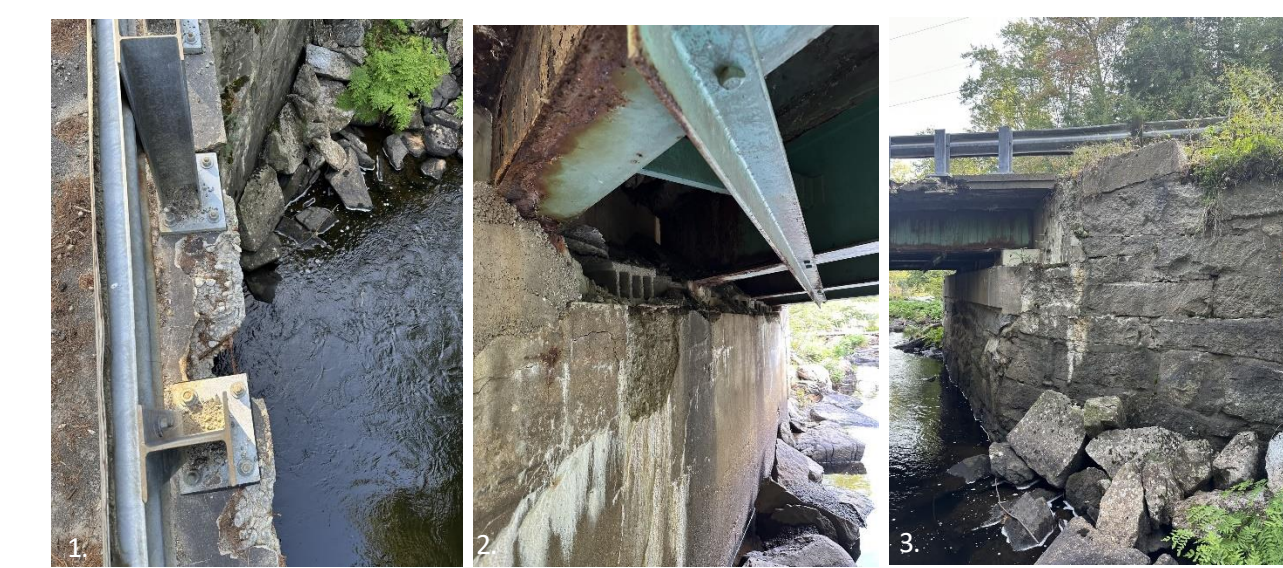
1. Deteriorating Deck
2. Section loss in steel girders/ cracking in east abutment
3. Section loss in west abutment

- Clothespin Bridge over Blackwater River, Webster, NH:
- Original construction unknown, rehabilitations were conducted in 1939 and 1954
 - Steel beam superstructure with 7-inch concrete deck
 - 65-foot clear span
 - 18-foot bridge with 20-foot approach (single lane)
 - Inspection in 2022 Rated the Bridge deck "2-critical", superstructure "5-fair", and substructure "4-poor"
 - The bridge has been listed on the NHDOT Municipal Red List since 2014

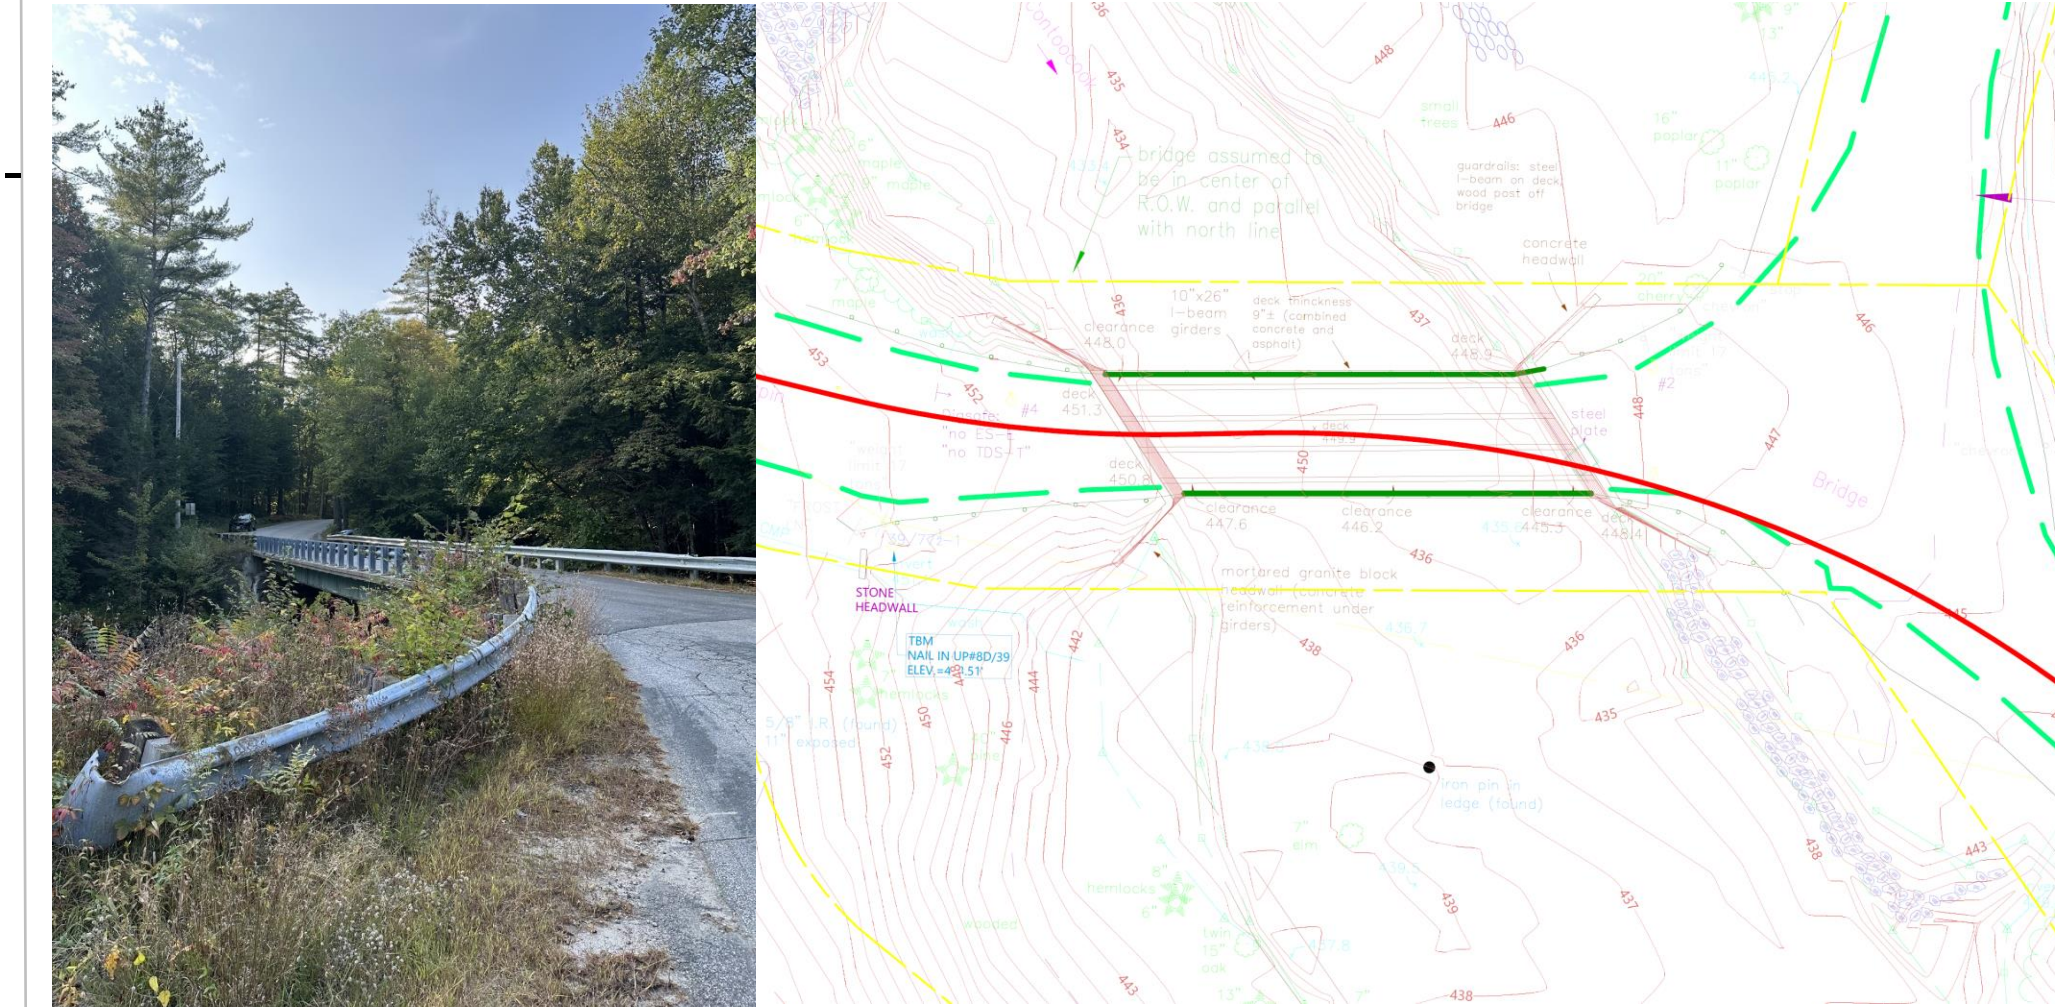
Existing Roadway

- Approach roadway width of 20 feet is satisfactory
- Vertical and horizontal alignment is substandard
- Bridge Clear width of 18 feet does not meet NHDOT 24-foot requirement

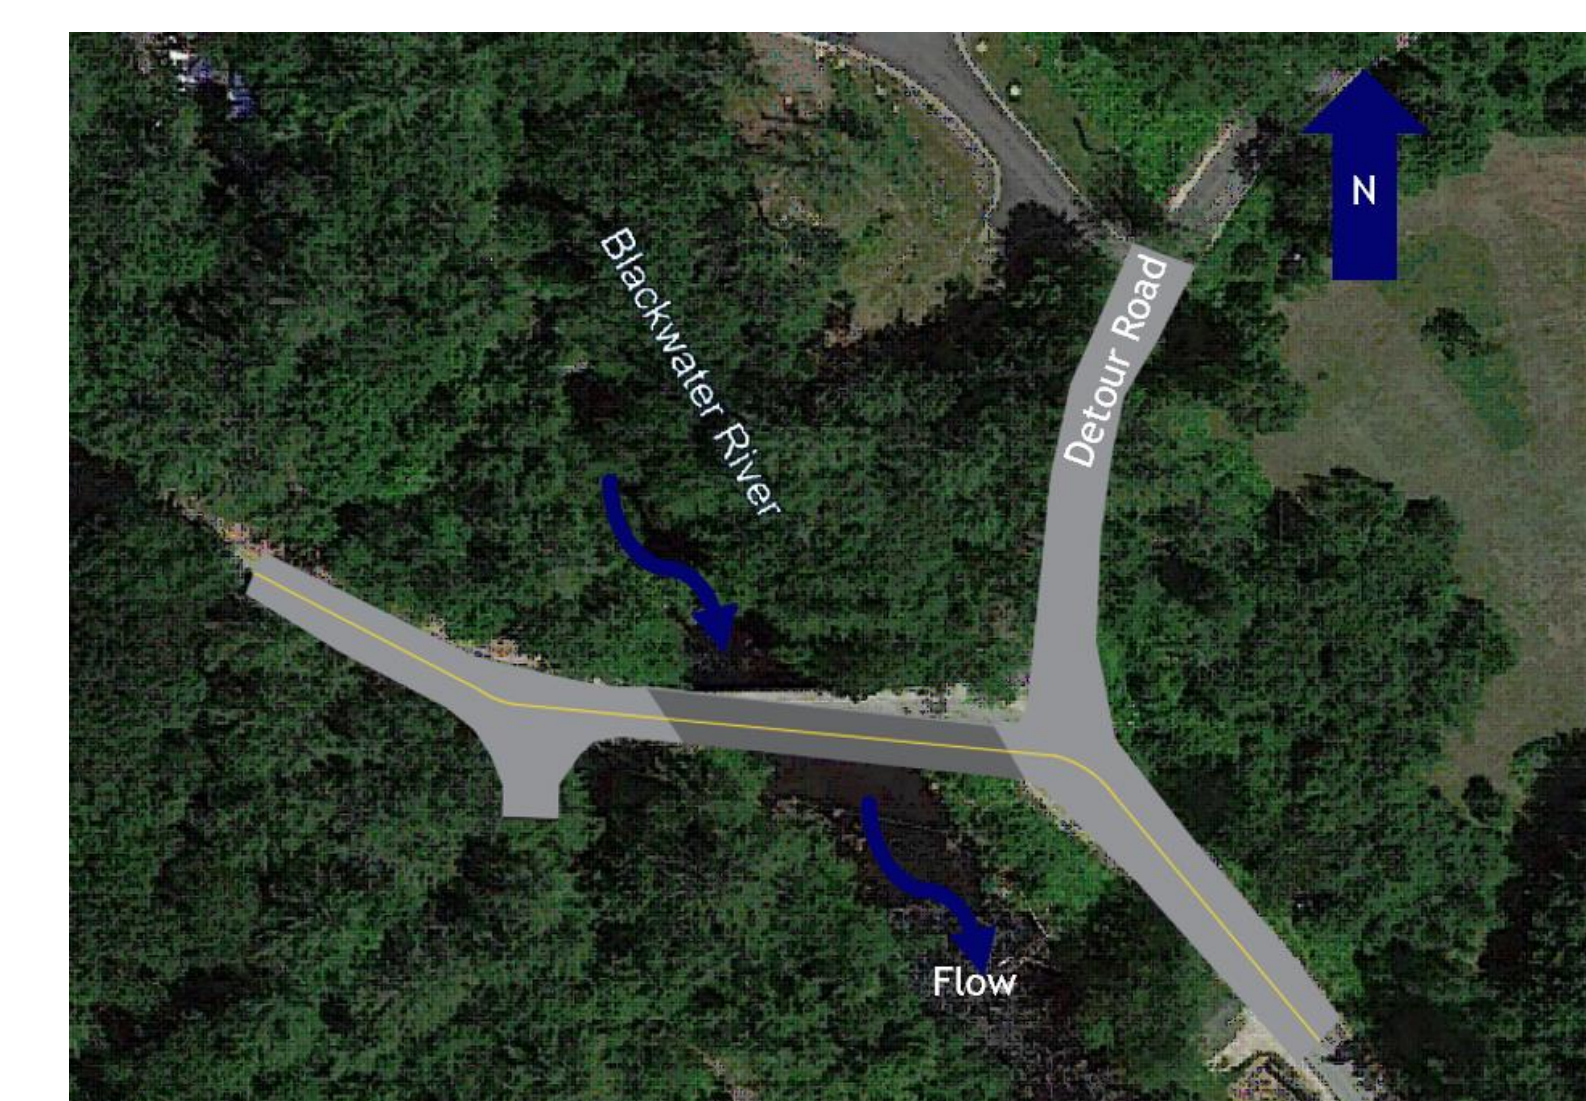
Roadway Alignment

An off-line alignment is the preferred bridge alignment. This will resolve the horizontal alignment issue and improve sight lines. This will result in a 107-foot bridge at a skew of 40 degrees.
