Harvard Museum of Comparative Zoology

Caleb Chinburg, Connor Deming, Payton Maddaloni, Susan Strickland

Department of Civil and Environmental Engineering, University of New Hampshire, Durham, NH 03824

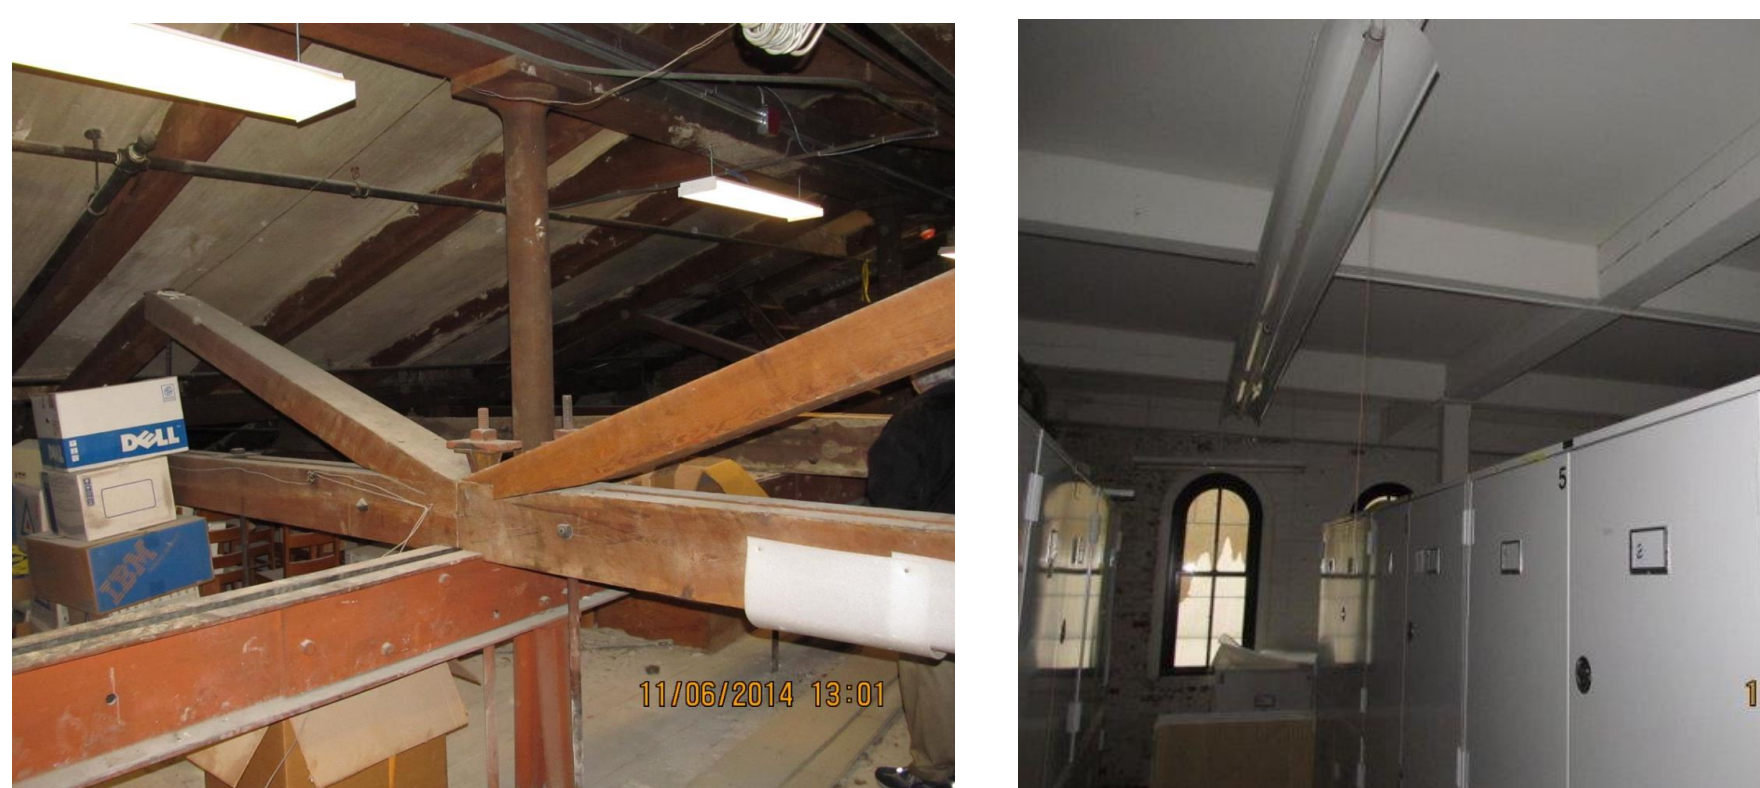
Area 1

- Fifth floor is supported by two different support systems
- North half is supported by a timber frame system
- South half is supported by a combination of brick archways and steel beams

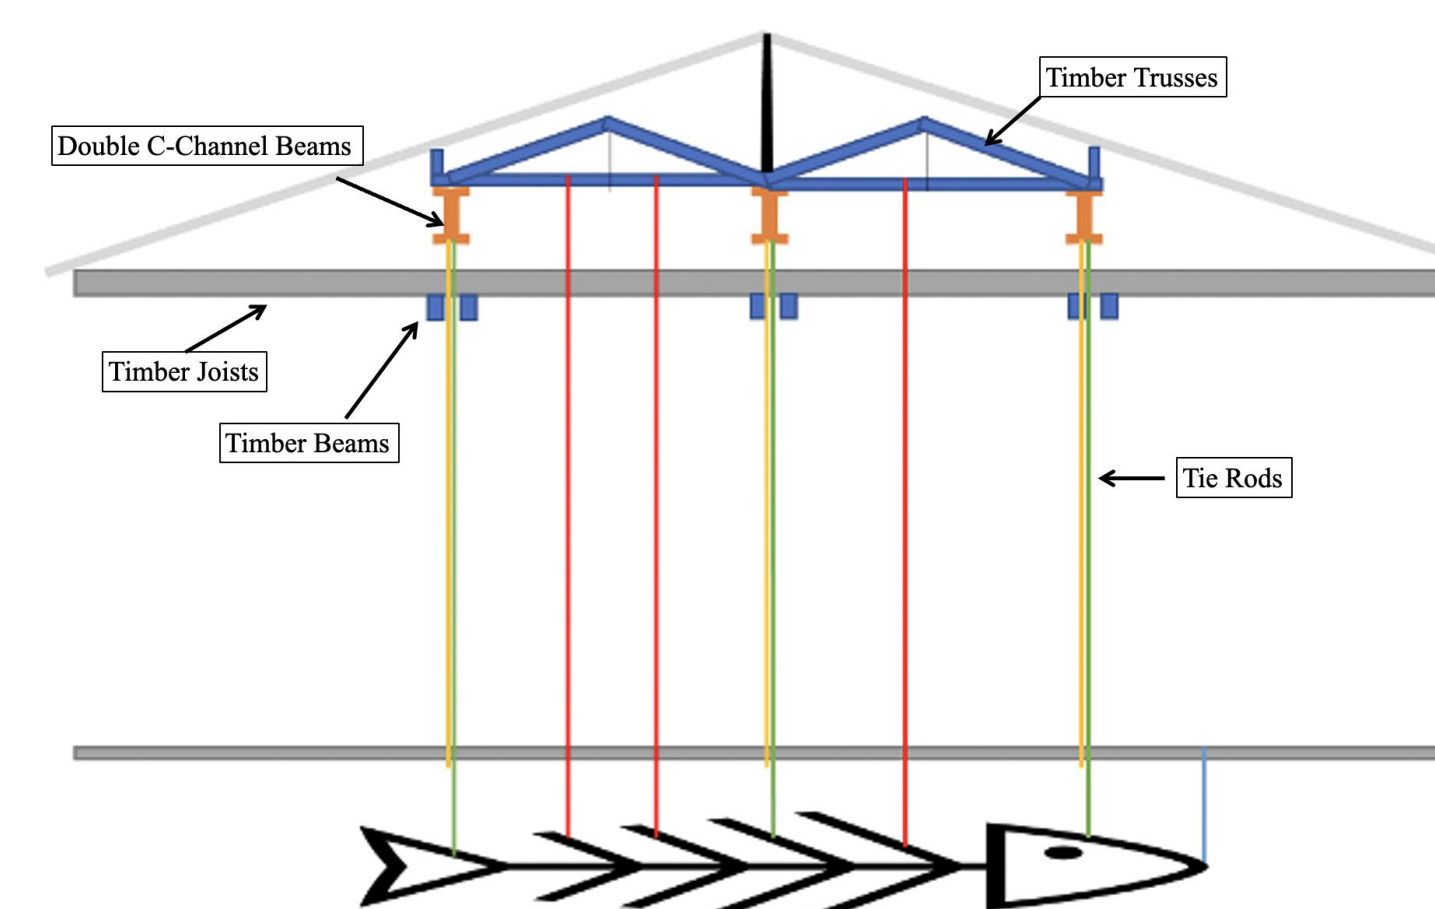
Area 2

- Fifth floor is hung from the attic with tie rods
- Double C-Channels in the attic support the floor and ceiling members
- A wooden truss system in the attic space serves to support whales that hang under the fifth floor

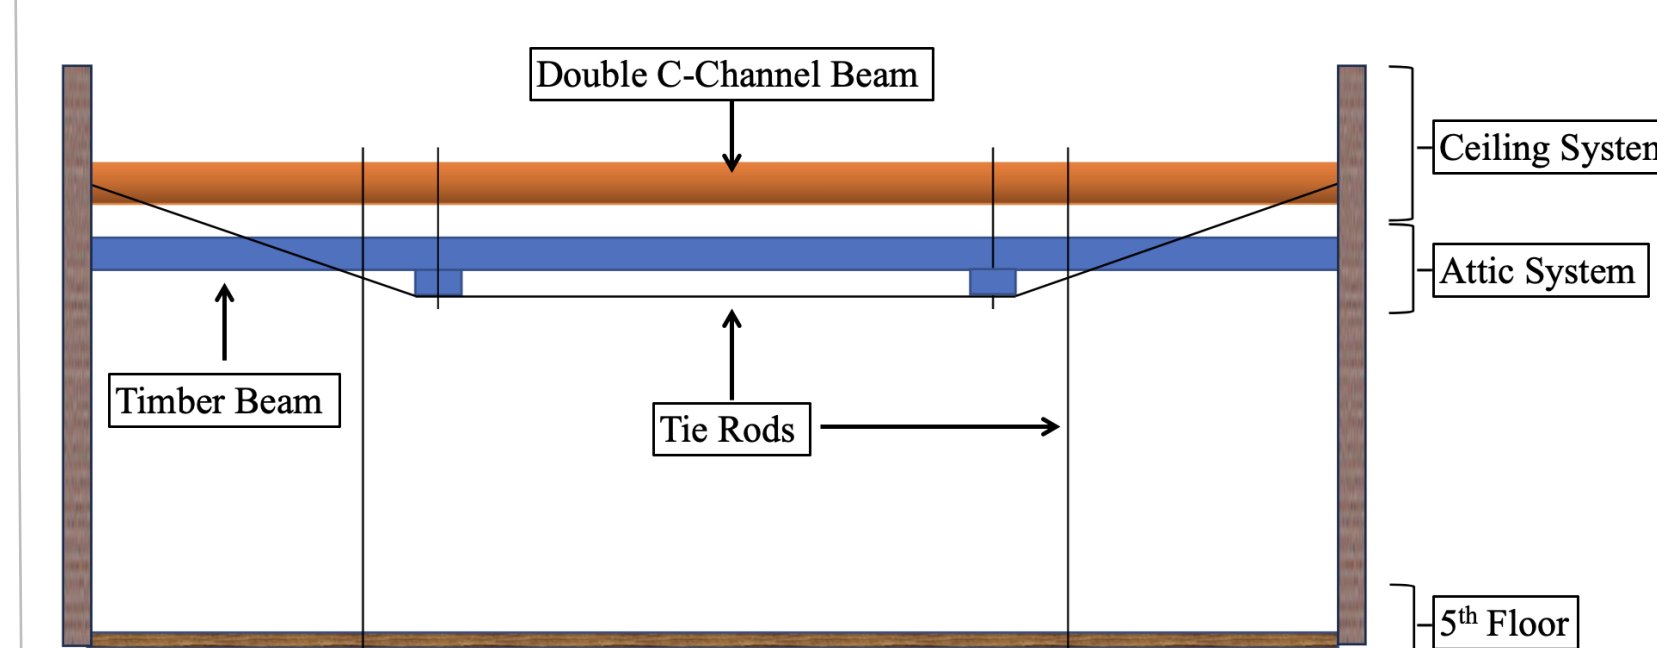
- With limited plans and pictures available it was assumed that Area 3 has a similar structural system to Area 2
- There were no whales to account for in this area and therefore no attic truss system
- A load-bearing brick wall cuts this area in half, taking on some of the load from the fifth floor

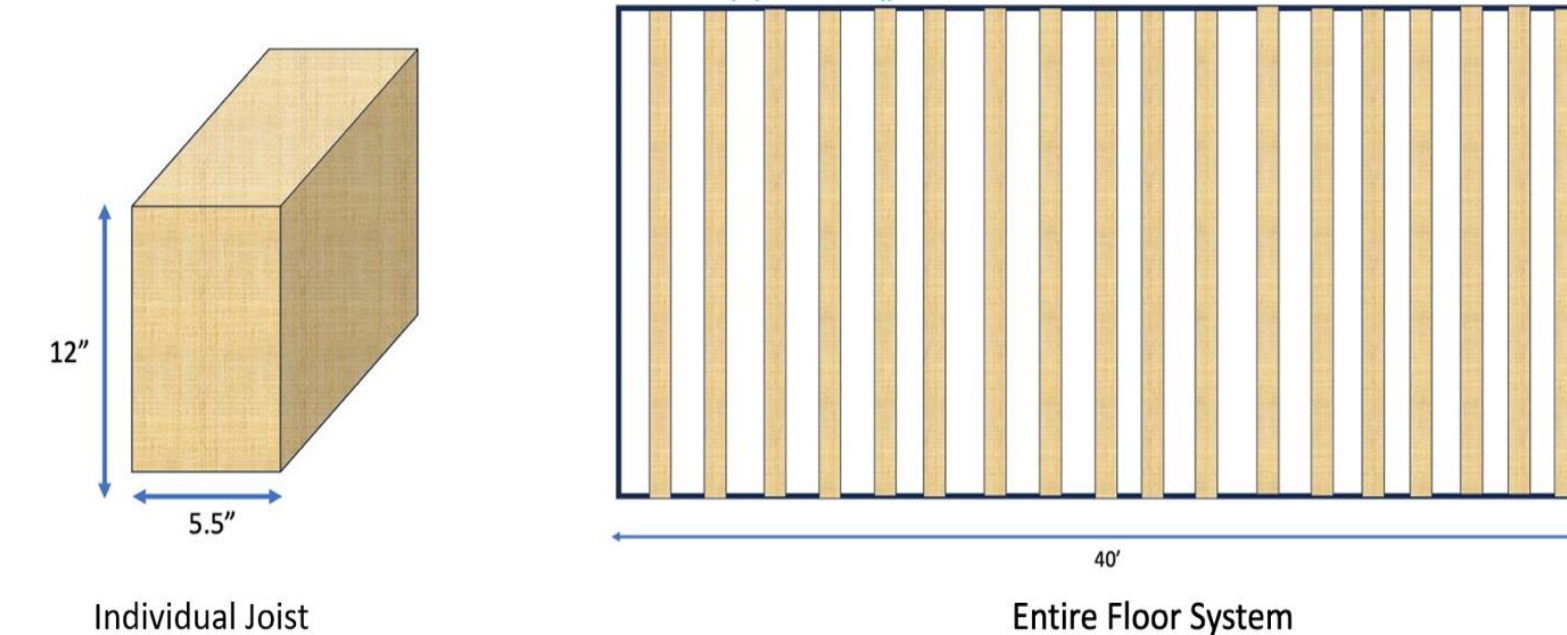
Area 4

- Constructed with a simple span, timber joist system
- Using plans from Area 2 the width of the room was determined
- Timber floor system and dimensions were then calculated
