Using Geospatial Analysis to Evaluate Stream Crossing Replacements in New Hampshire

Connor Paul (connor.paul@unh.edu) and Sebastian Eid (sebastian.eid@unh.edu)
 Advisor: Anne Lightbody (Department of Earth Sciences UNH), Project Co-leader: Brian Hauschild (NHDES)
 University of New Hampshire: Department of Earth Sciences, Durham, NH 03824

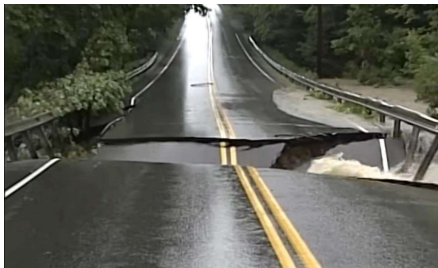
Fig. 1: Culvert failure during large flood in Freeport, Maine, in August 2008

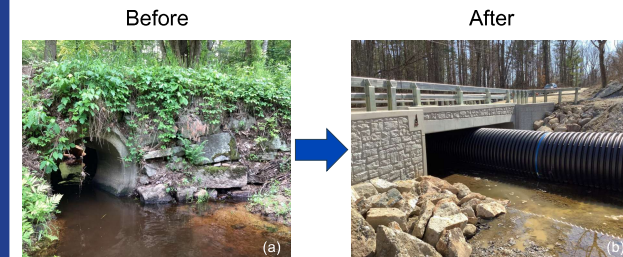
Fig. 4: Culvert in Barrington where we conducted field measurements. (a) Prior to reconstruction, this culvert regularly backed up and overtopped during large rain events. 2023 archive photo by NHGS. (b) Following reconstruction, the culvert tripled in size and was reinforced with wingwalls. The black pipe was a temporary redirection of flow and will be removed following construction. Photo by Connor Paul.

- When in the field, we measured and photographed elements of the reconstructed culvert that affect flood capacity. These measurements included width, height, slope, and stream size. We also noted features such as beveled entryways, angled wingwalls, reinforcements, and sloped sidewalls
- The type and shape of the structure, as well as the undercutting, pooling, drop-off, or damming were also noted as these factors affect flood control as well as geomorphic compatibility and aquatic organism passage
