# METAL WAREHOUSE ROOF COLLAPSE INVESTIGATION

Sarah Moriarty, Brandon Loisel, Marco Gioioso, Alex Croteau  
 Sponsor: Simpson Gumpertz & Heger  
 Faculty Advisor: Dr. Ray Cook

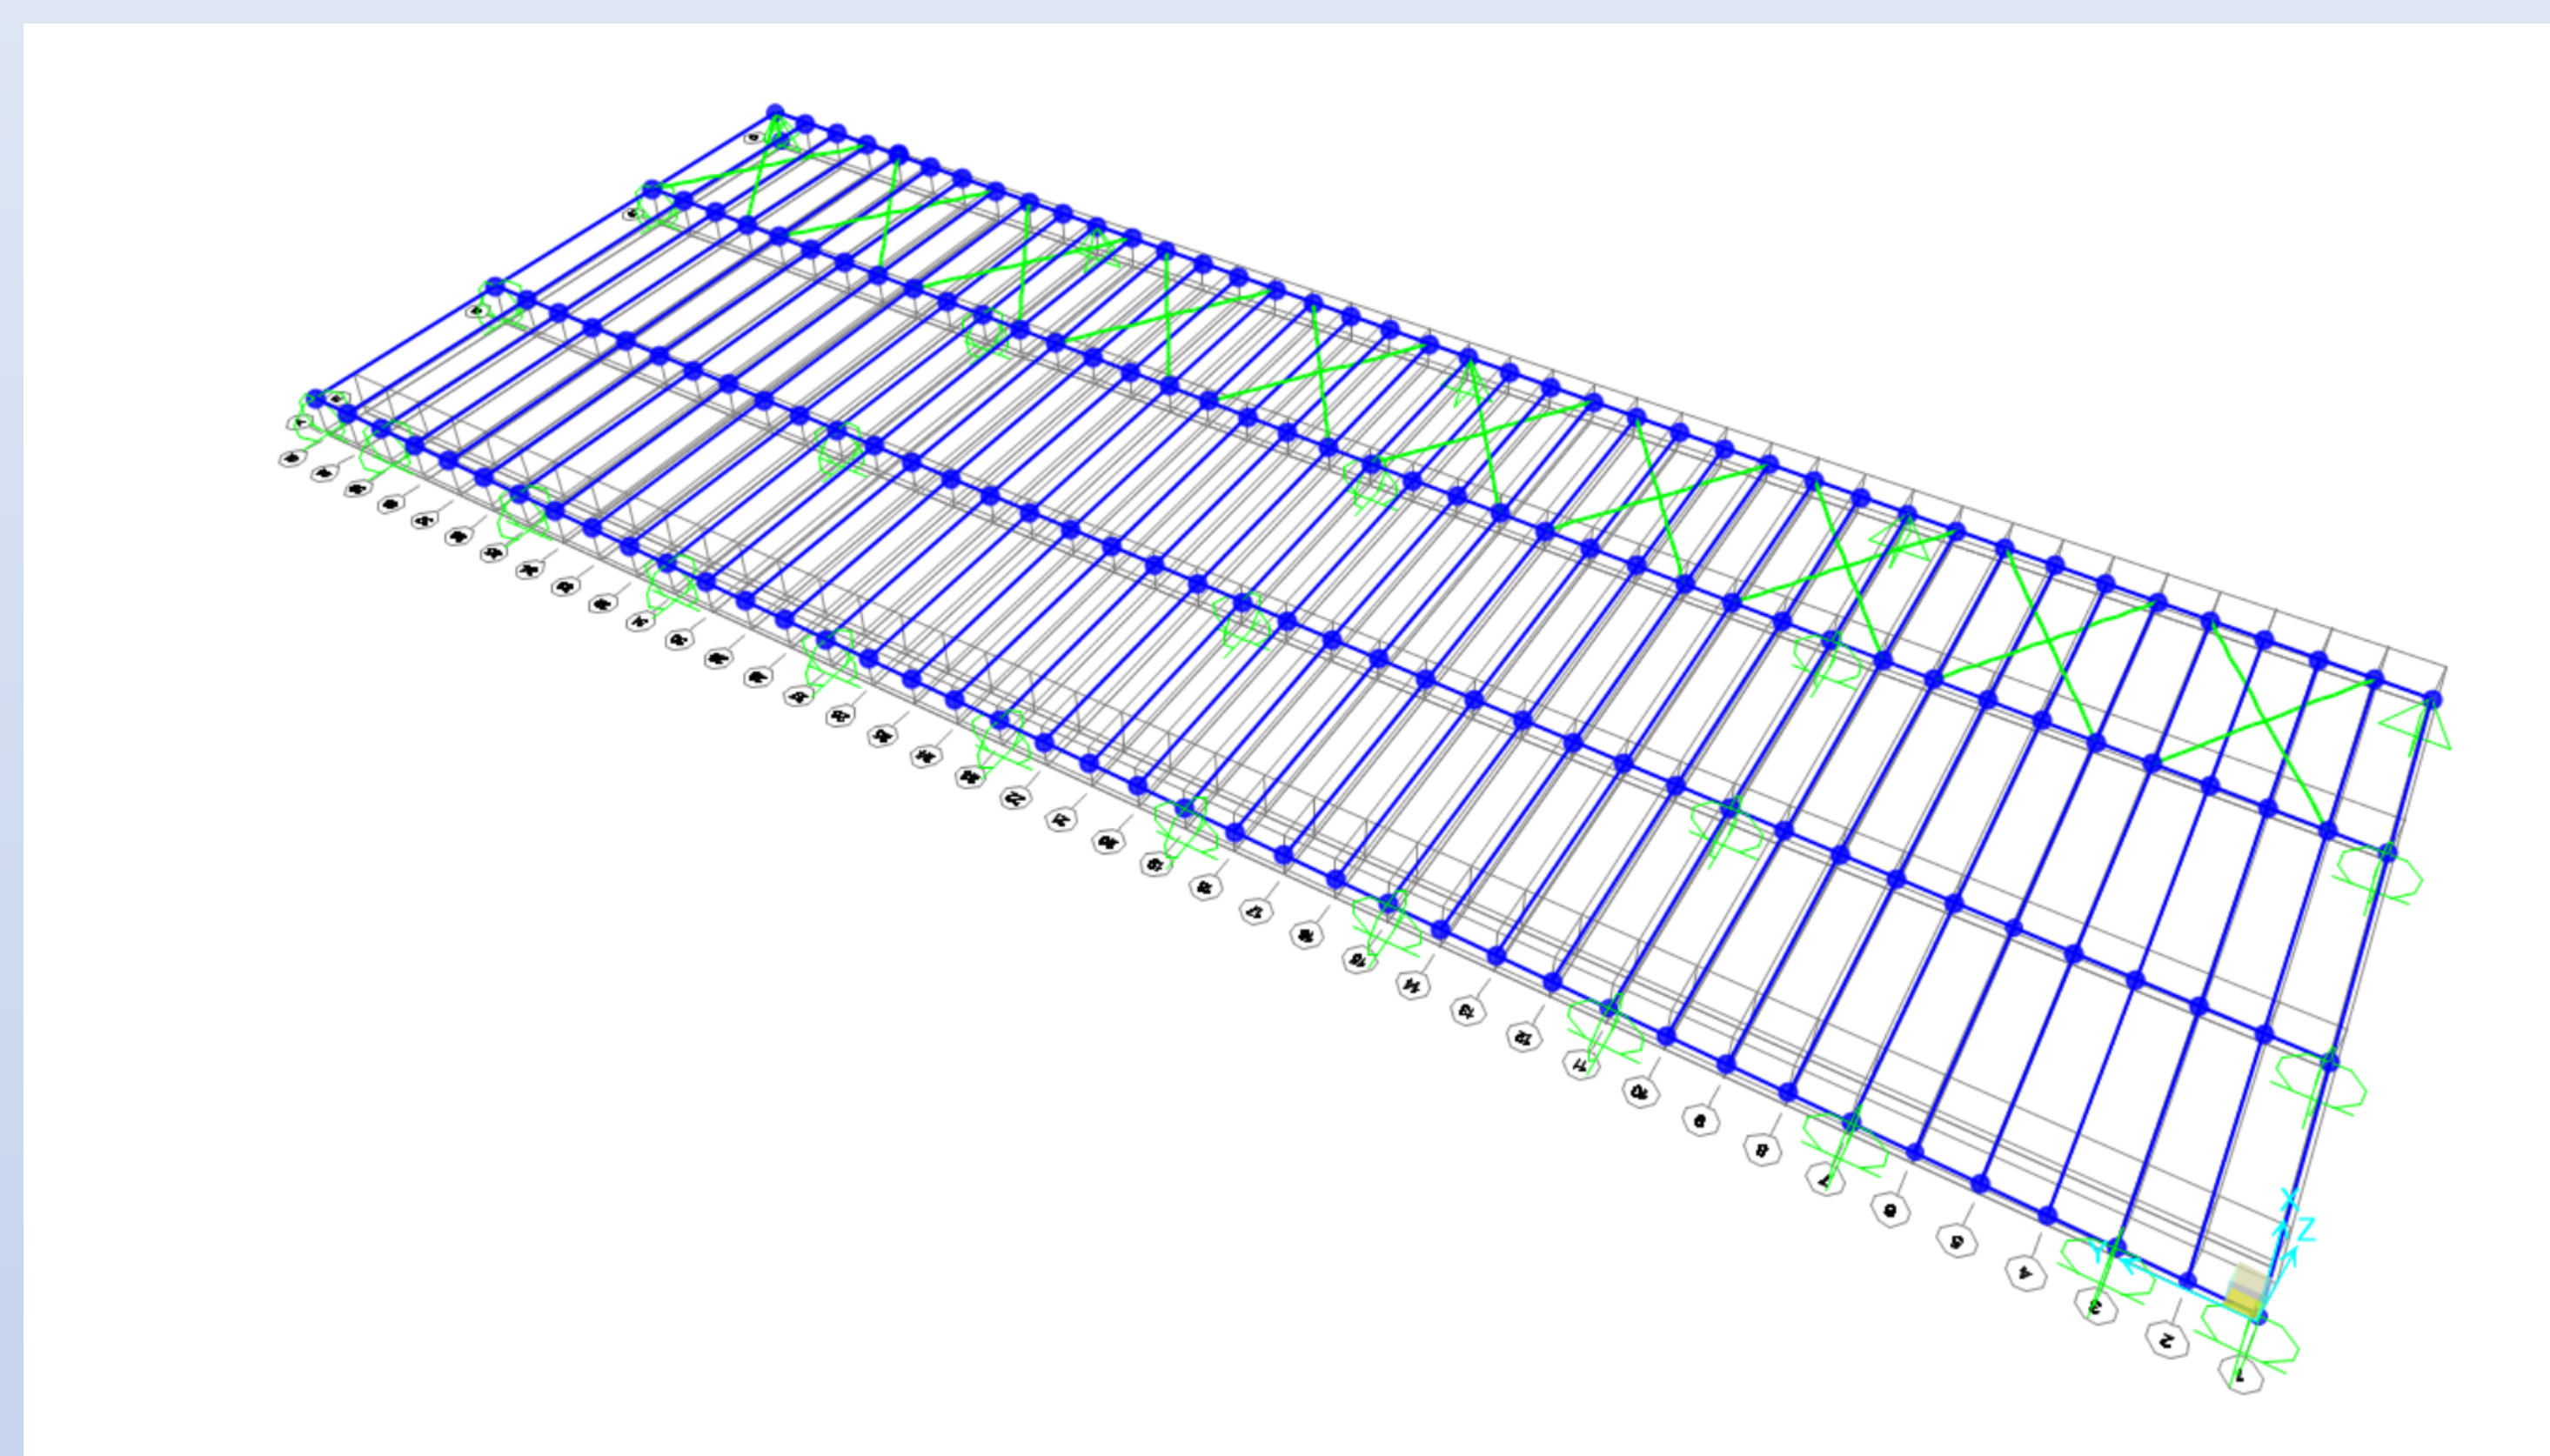
Figure 1: SAP 2000 Analytical Model

The next portion entailed analysis to prove that the suspected mode of failure did in fact cause collapse. To begin, a model was created. Using a variety of information, SG&H sourced documents, codebooks and historical data, the best representation of the structure was produced. The expected loads were then generated by using NOAA weather data for snow loads and the assumption made by the group.

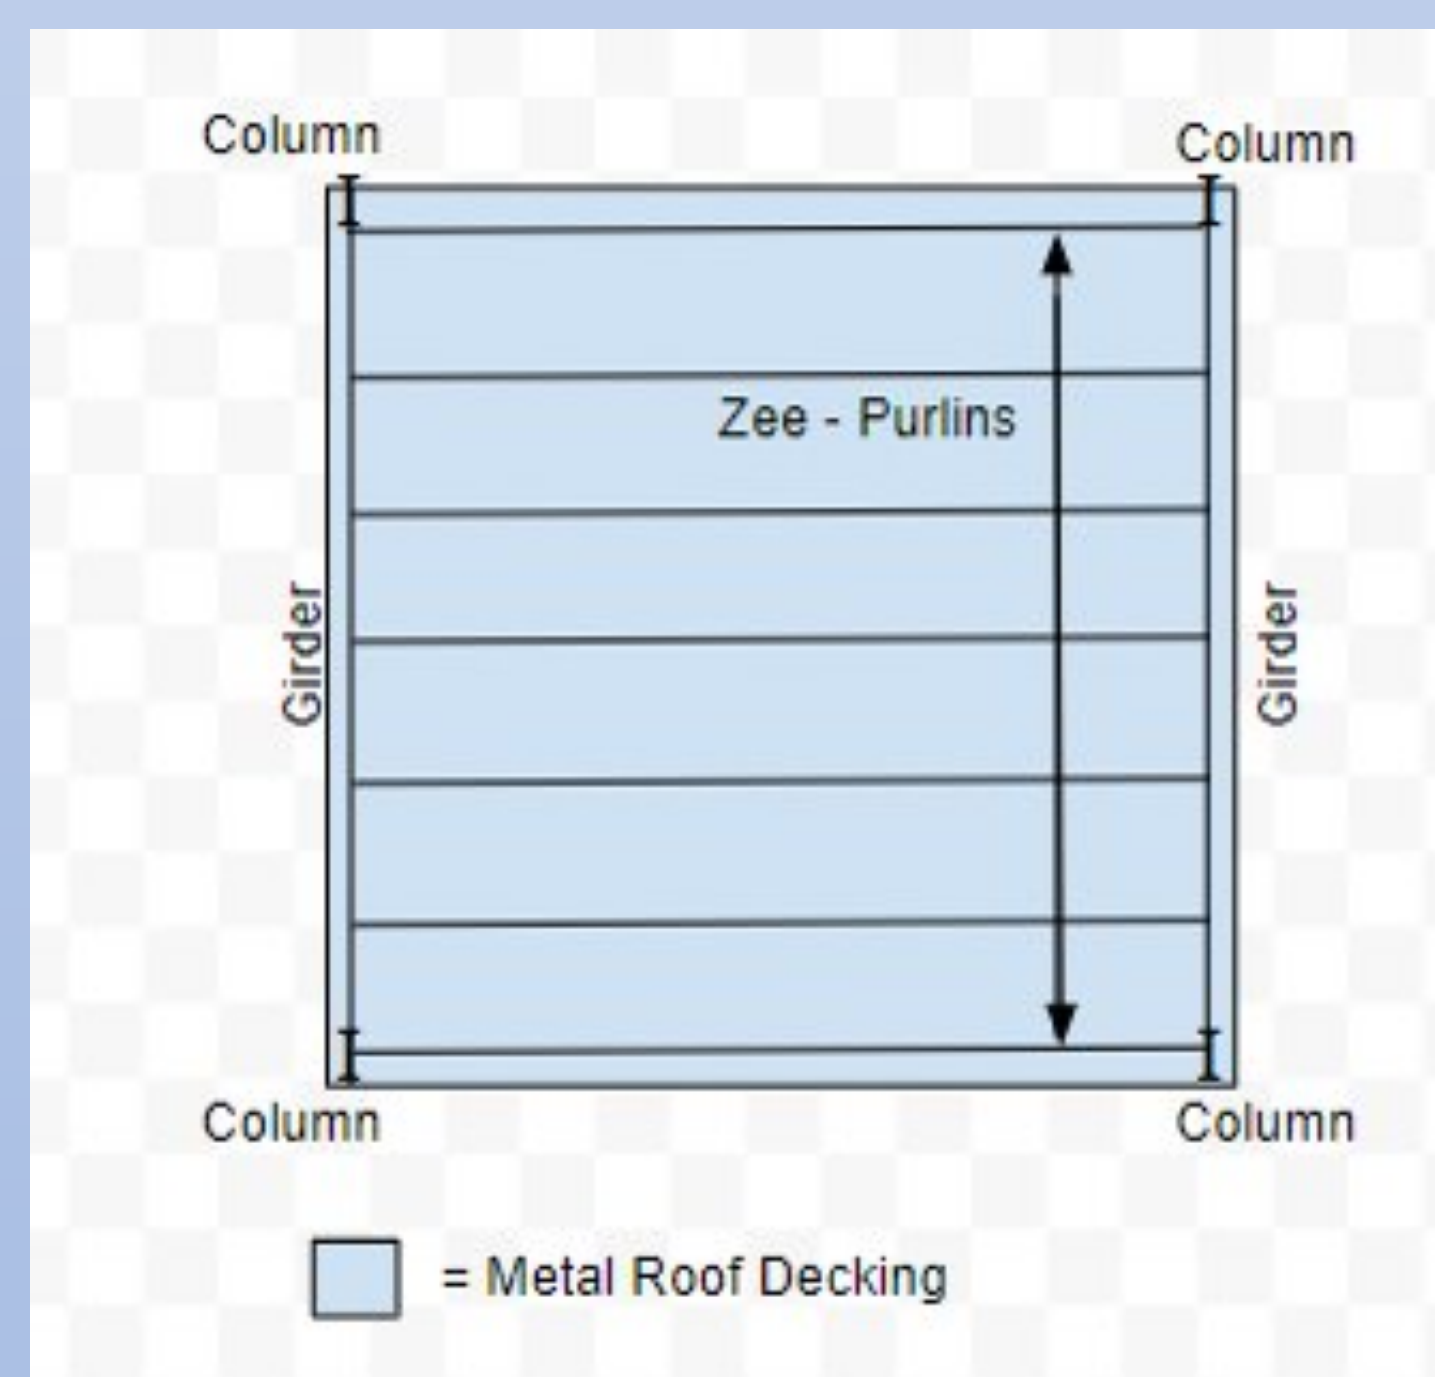
Figure 8: Load Path

**Load Path**  
 Load => Decking => Purlin => Girder => Column => Foundation => Soil
