Cost Savings Through Automated Quality Inspection Using A Smart Camera

Department of Electrical and Computer Engineering, University of New Hampshire

Goal: Design and build an inspection system to identify imperfections for the 2023 Honda Pilot side panel that provides a financial benefit to the company.

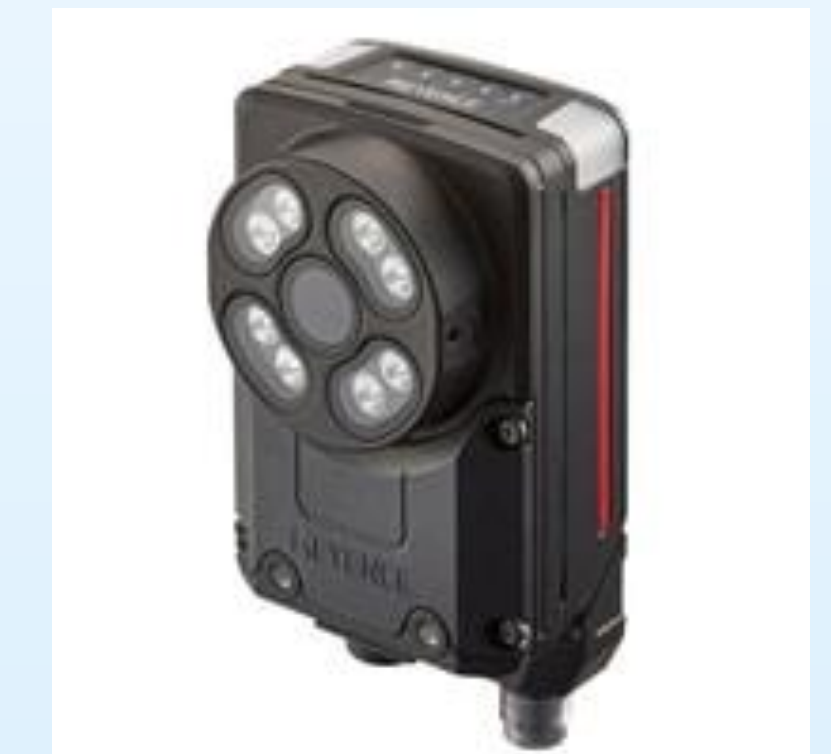
- Keyence IV-3
- Neural Network Training
 - Cheaper: \$5,000
 - Lacks Data Matrix Reader

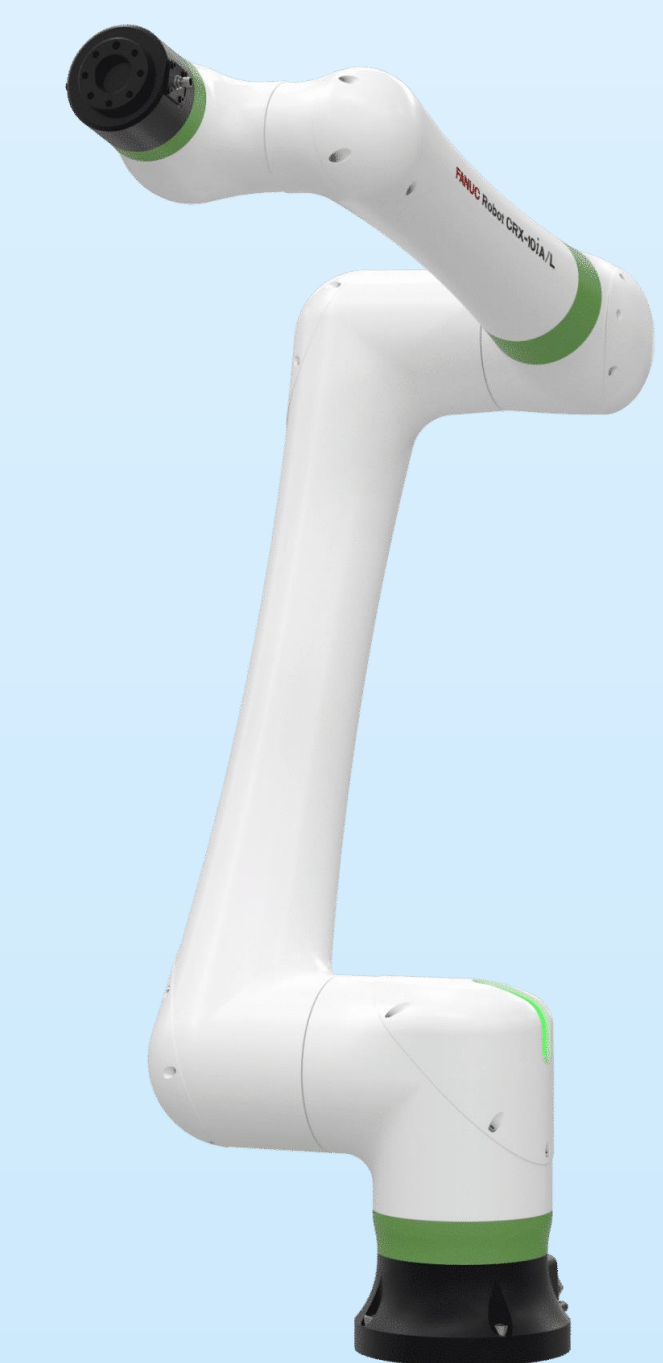
Fanuc CRX-10iA

- Fanuc’s cobot
- More familiar interface
- More expensive: \$30,000
