# Oyster Biosensors: Measuring Farmed Oyster Health and Related Water Quality

Joshua Kazmer<sup>1</sup>, Skye Flegg<sup>2</sup>, Arjun Sahni<sup>2</sup>, Michaela Edwards<sup>2</sup>, Easton White<sup>2</sup>, Brittany Jellison<sup>2</sup>

1. College of Engineering and Physical Sciences, University of New Hampshire 2. Department of Biological Sciences, University of New Hampshire

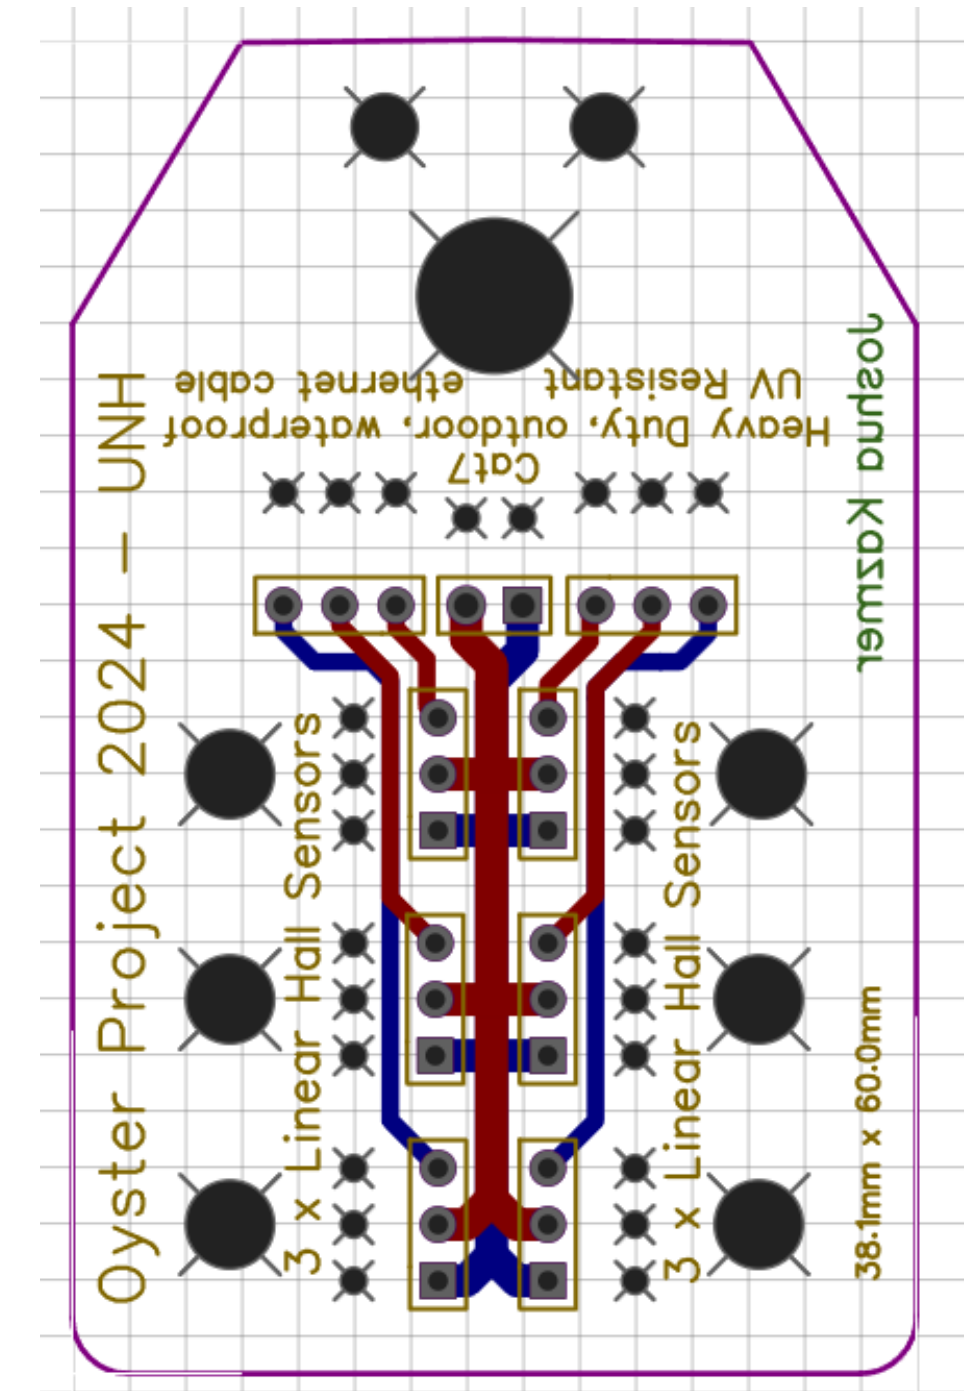
Figure 1. PCB Wiring of Ethernet Split

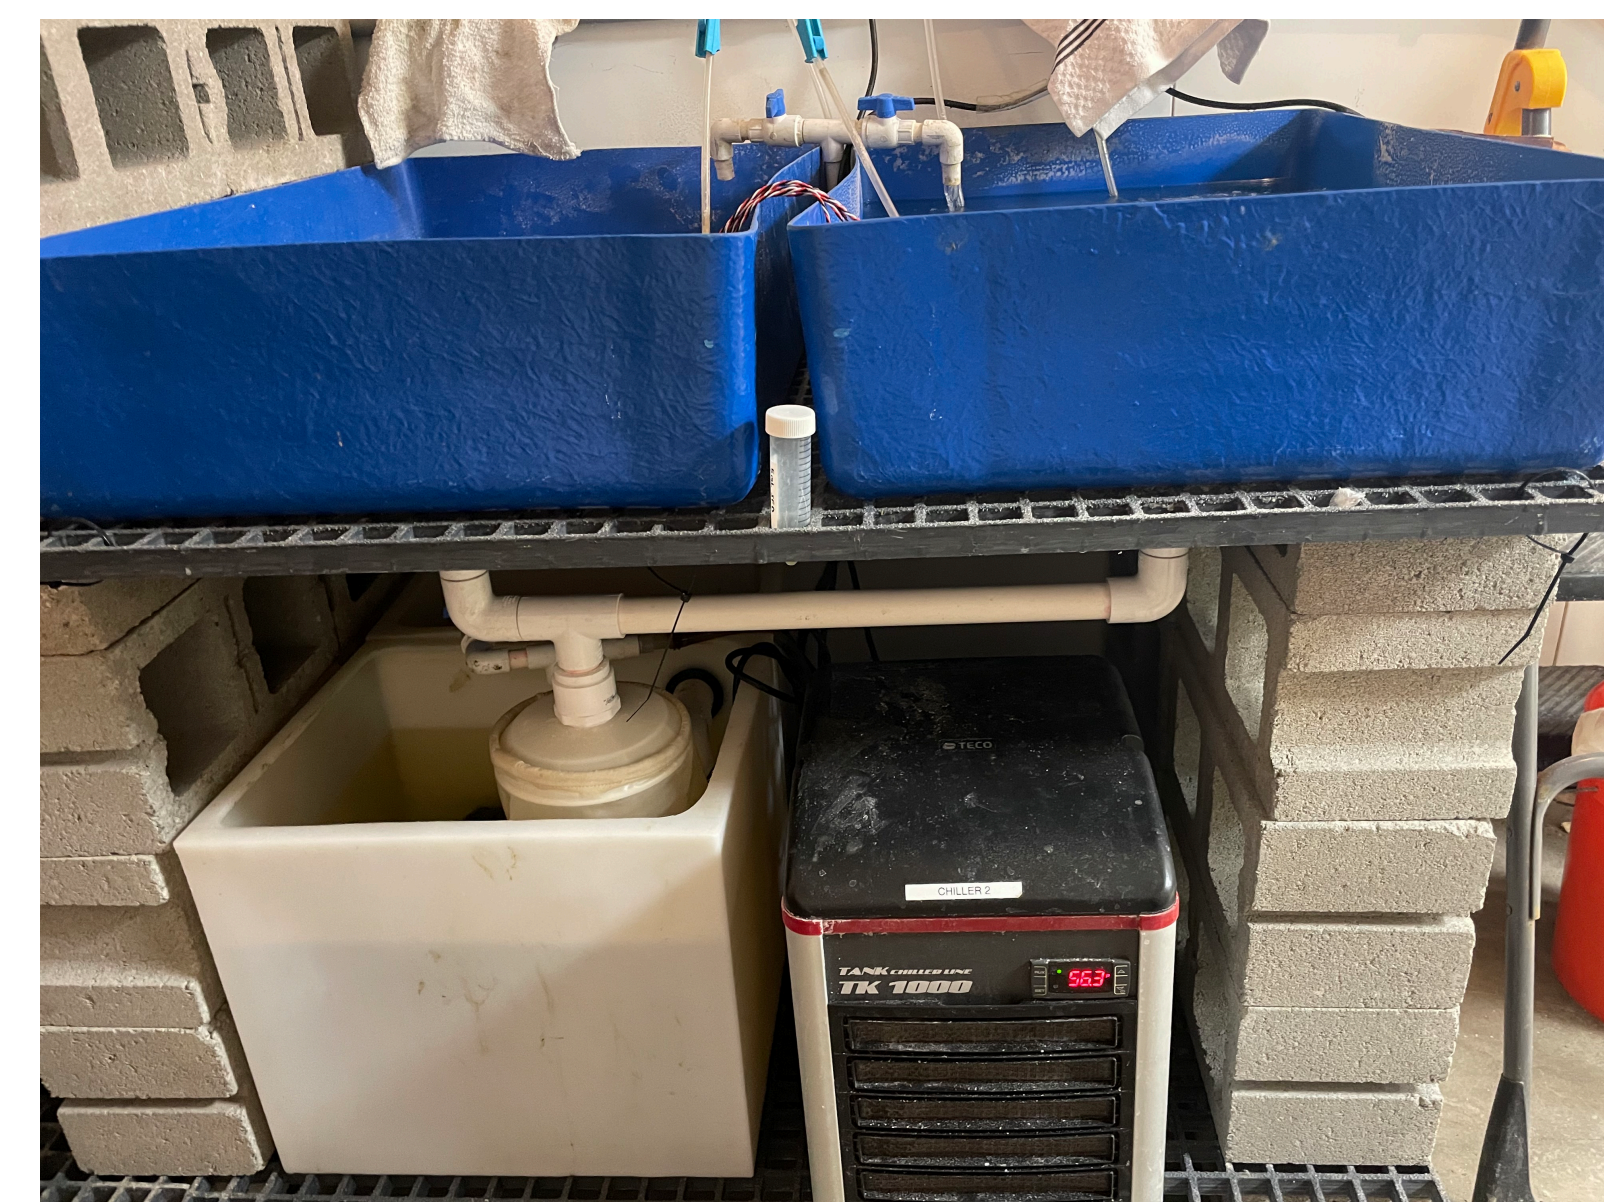
Figure 5. Kendall Hall experimental set up in flow through tank with bag filter, water pump, water chiller, and aerators

- Lab testing in Kendall hall confirmed water proofing is suitable for multiple days
- Data was collected continuously by the system and uploaded to the SD card

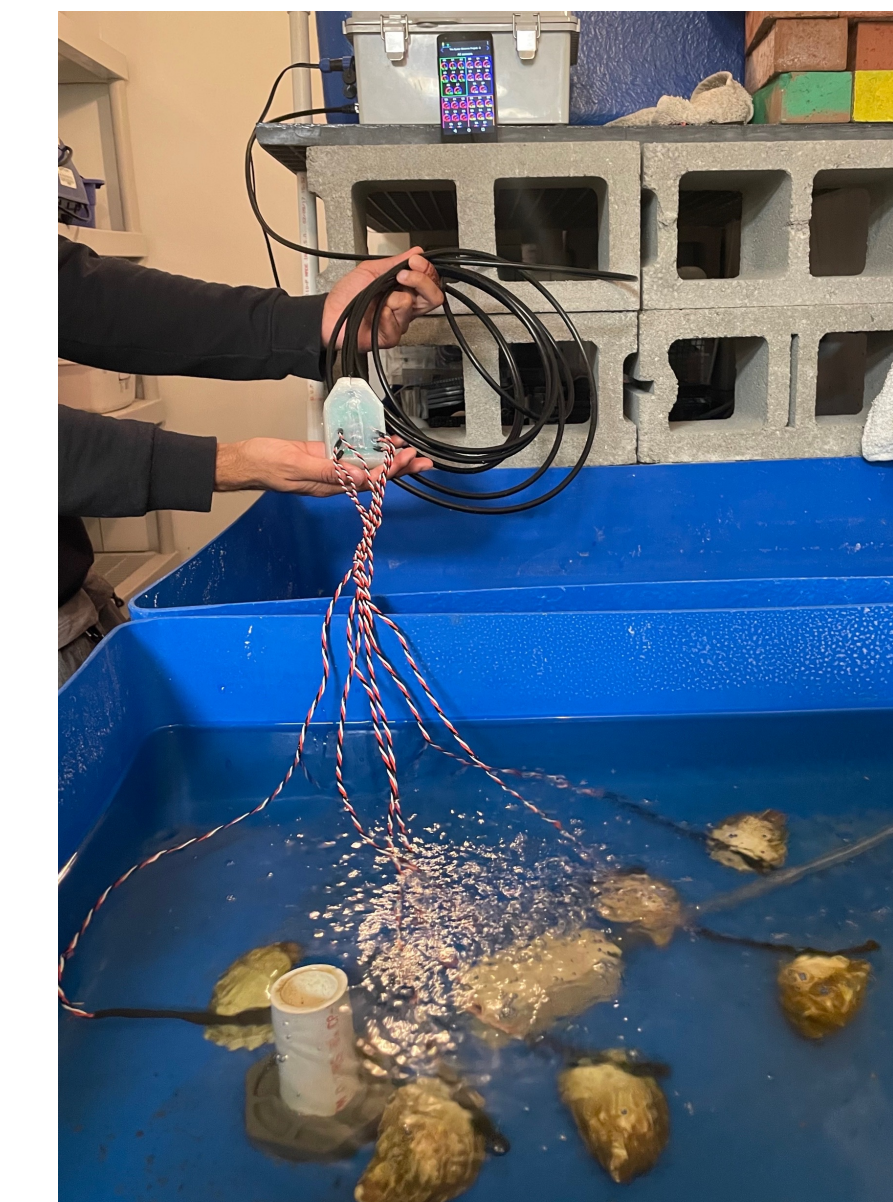
Figure 6. Above view of flow-through set up with full sensor system
